ST. MARY DIVERSION and CONVEYANCE FACILITIES

Failure and O&M Reference Guide

January 2010 (Final)

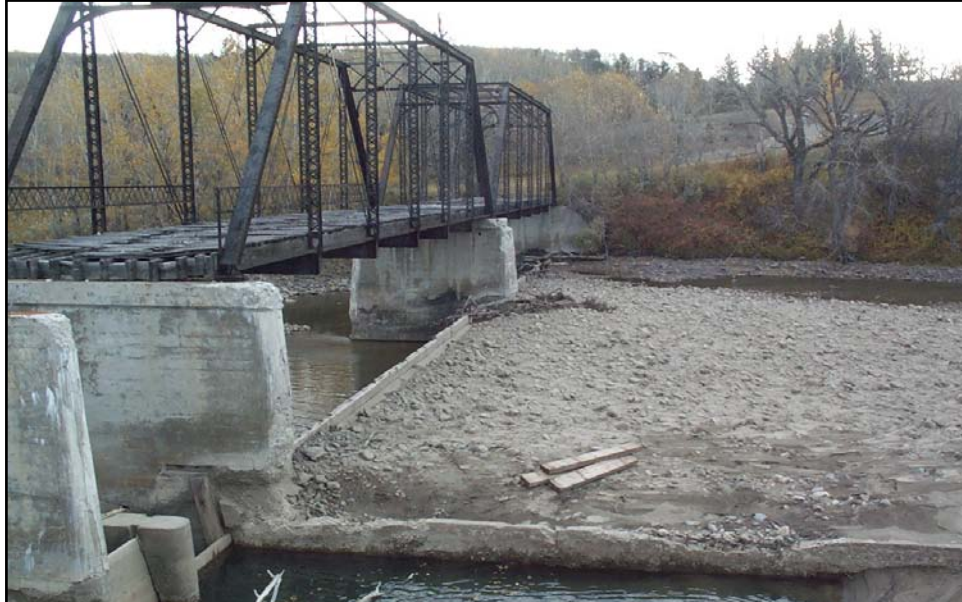
Photo 1. Looking east across St. Mary River during the off-season at the two fixed weir segments below the remaining bridge spans. Note condition of concrete, magnitude of sediment deposition upstream of dam and timber plank added to fixed weirs (10/06/04).

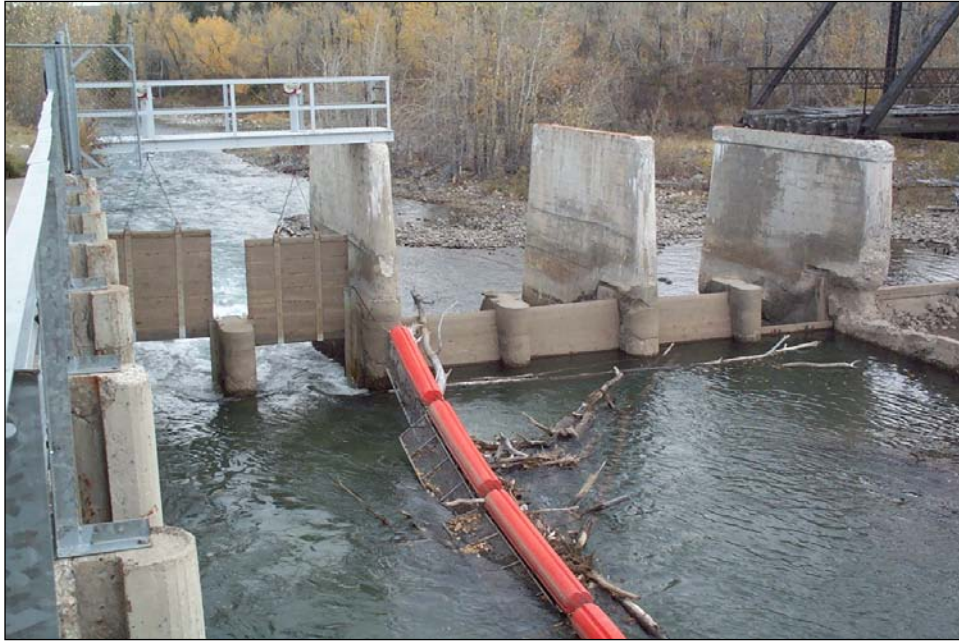
Photo 2. Looking downstream (north) at three sluiceways and 6 bays on the west side of diversion dam. Canal headgates are left of photo. Note two manually operated lift gates used to regulate flow and permit passage of off-season flow (10/06/04).

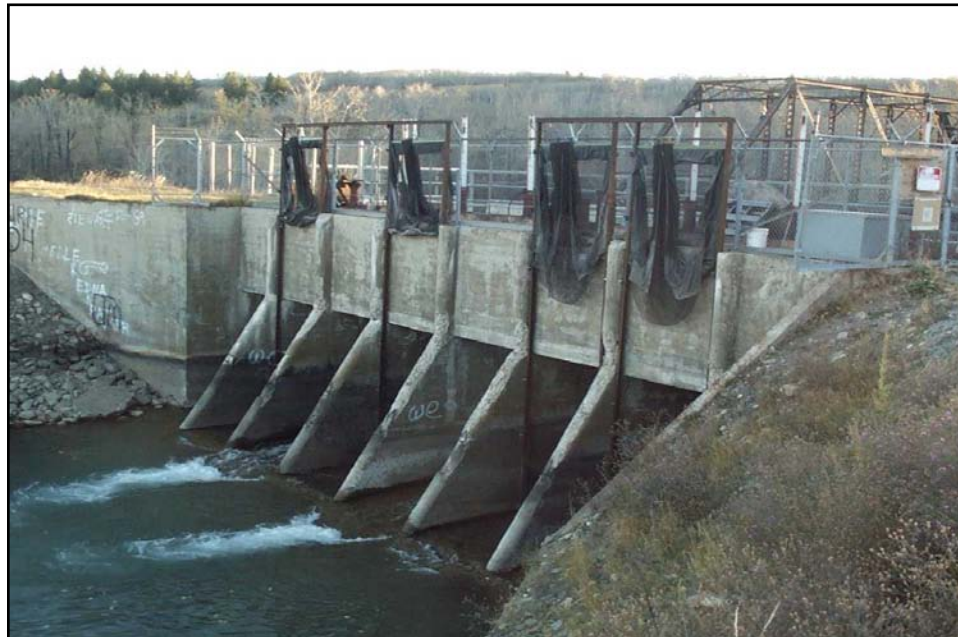
Photo 3. Looking at downstream end (canal side) of headgate structure. Diversion dam is located behind headgates (10/13/04).

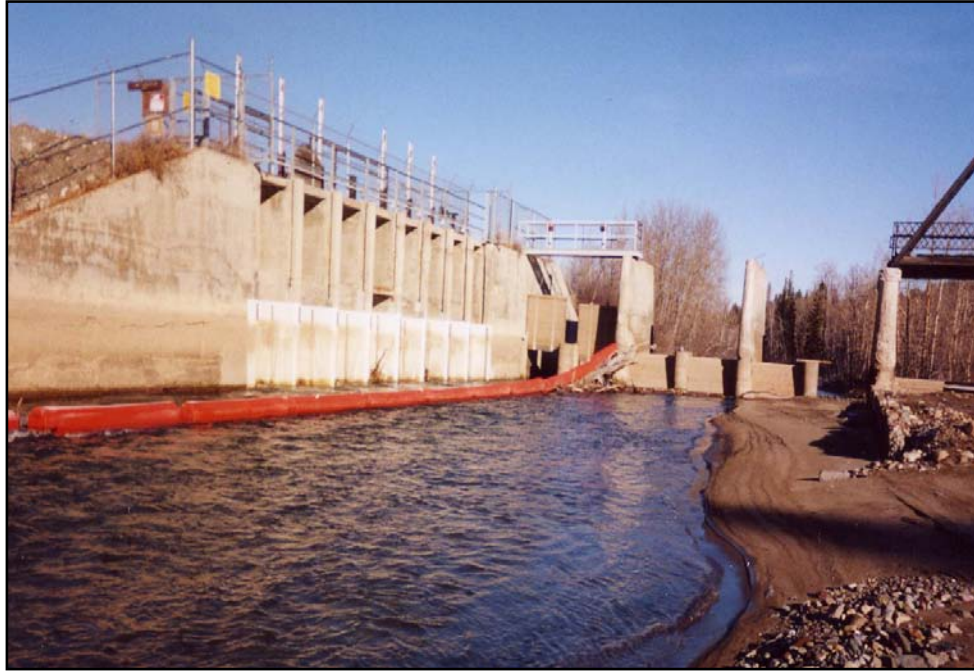
Photo 4. Upstream view of headgates showing trash boom, electric fish barrier, and dam sluiceways (11/11/04).

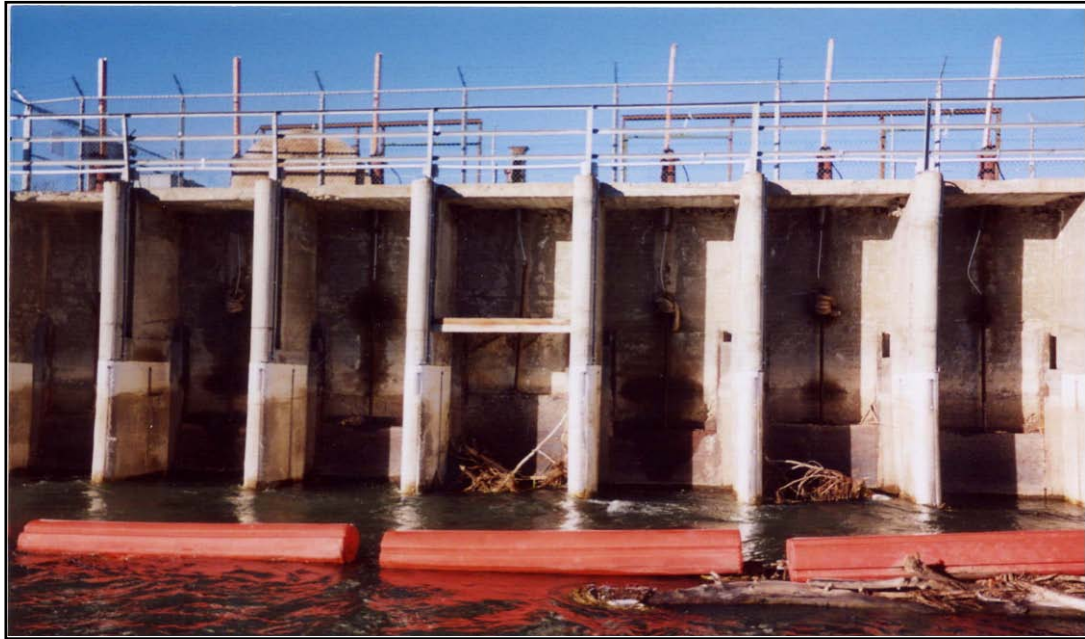
Photo 5. Upstream view of gate openings (11/11/04).

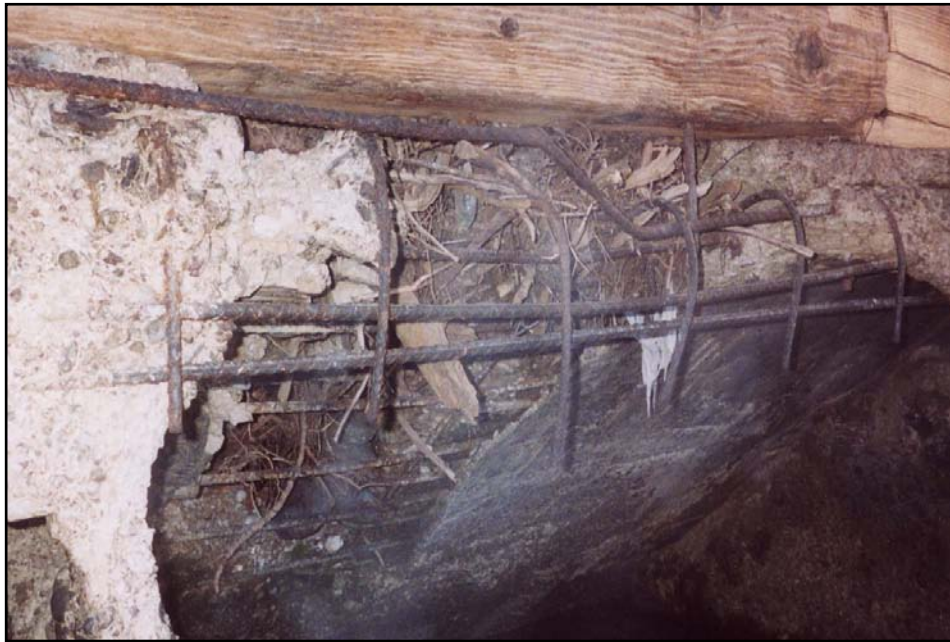
Photo 6. View of concrete condition of the underside of fixed weir portion of diversion dam (11/11/04).

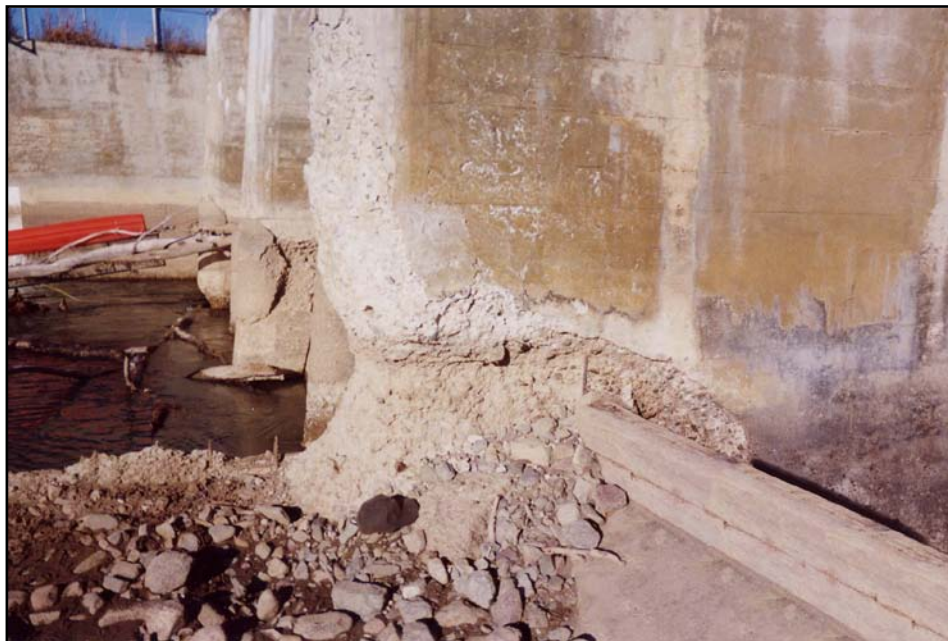
Photo 7. Looking west at upstream edge of sluiceway piers. Note concrete condition and exposed reinforcement (11/11/04).

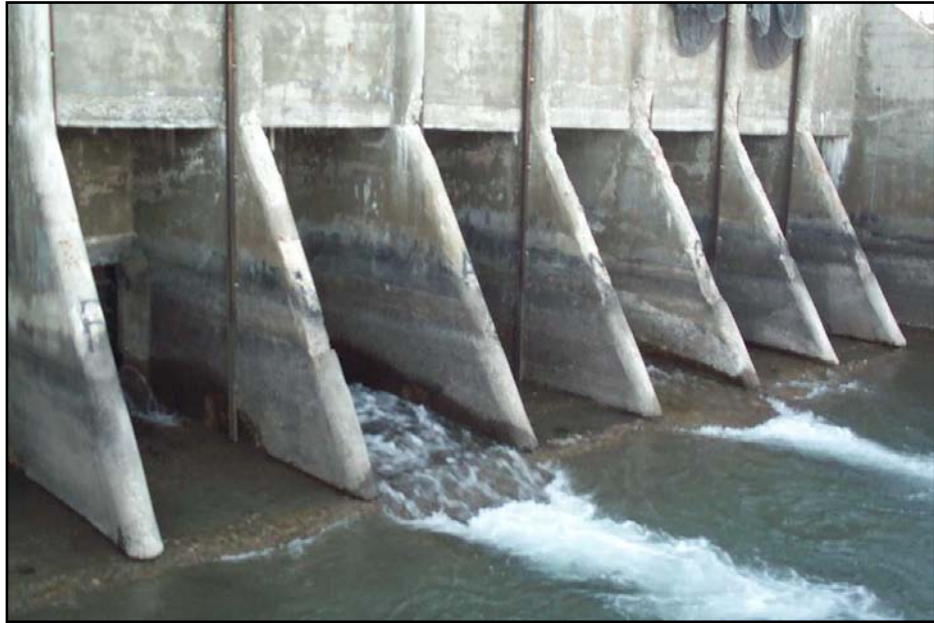
- Gates adjusted throughout season depending on desired canal flow
- Manually monitored and adjusted
- Closed during off-season but do not seal adequately resulting in leakage and ice problems (Photos 8 and 9)
- Concrete deterioration
- No effective fish deterrent to reduce canal entrainment
- Trash buildup
- Limited safety features

Photo 8. Downstream view of headgate structure during the off-season. Note heavy leakage through Gates 3 and 5 (10/13/04).

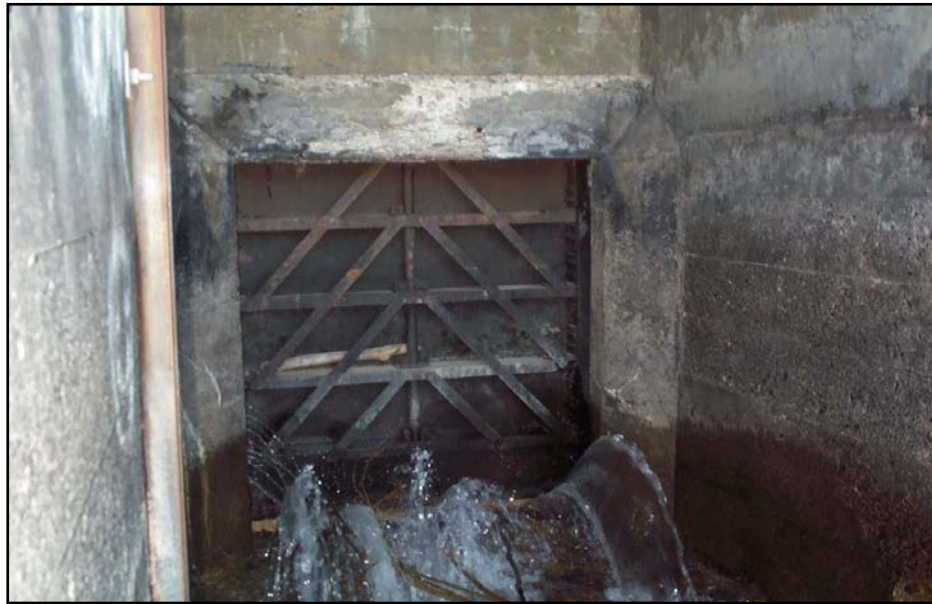
Photo 9. Close-up (downstream) of heavy leakage and debris at Gate 3 (10/13/04).

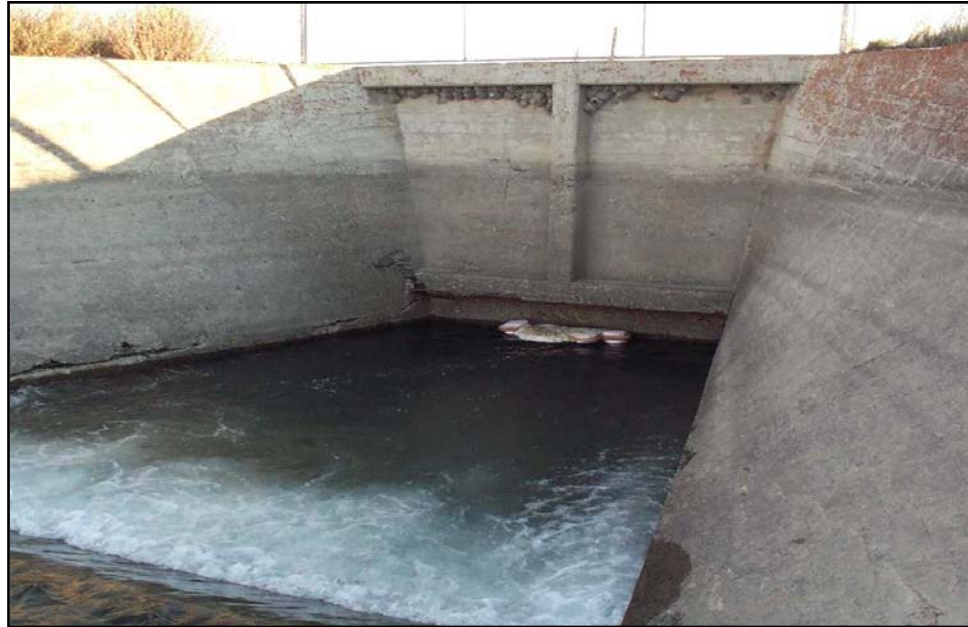
Photo 10. Inlet section (south side) of Kennedy Creek siphon during off-season (10/13/04).

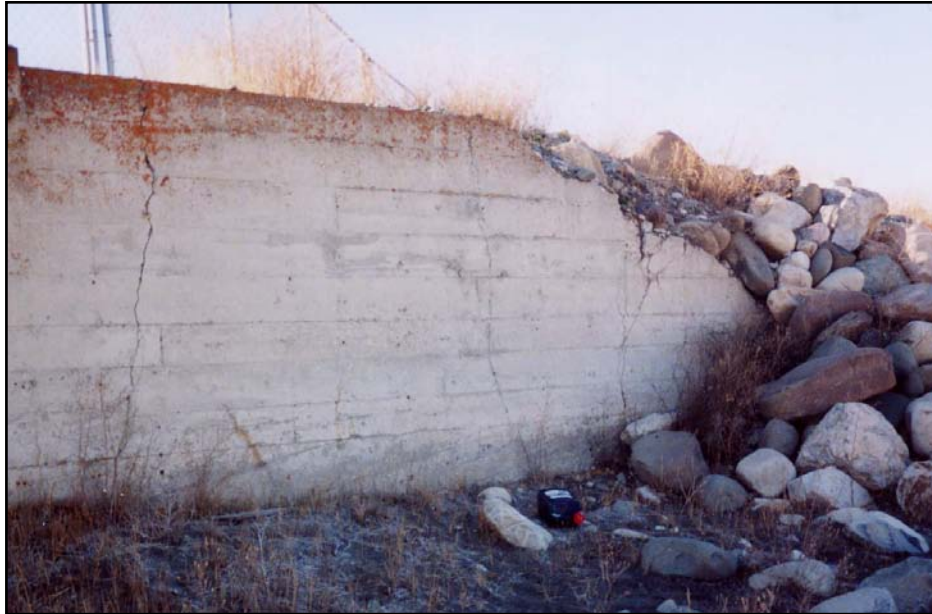
Photo 11. Kennedy Creek side of inlet transition structure (11/11/04).

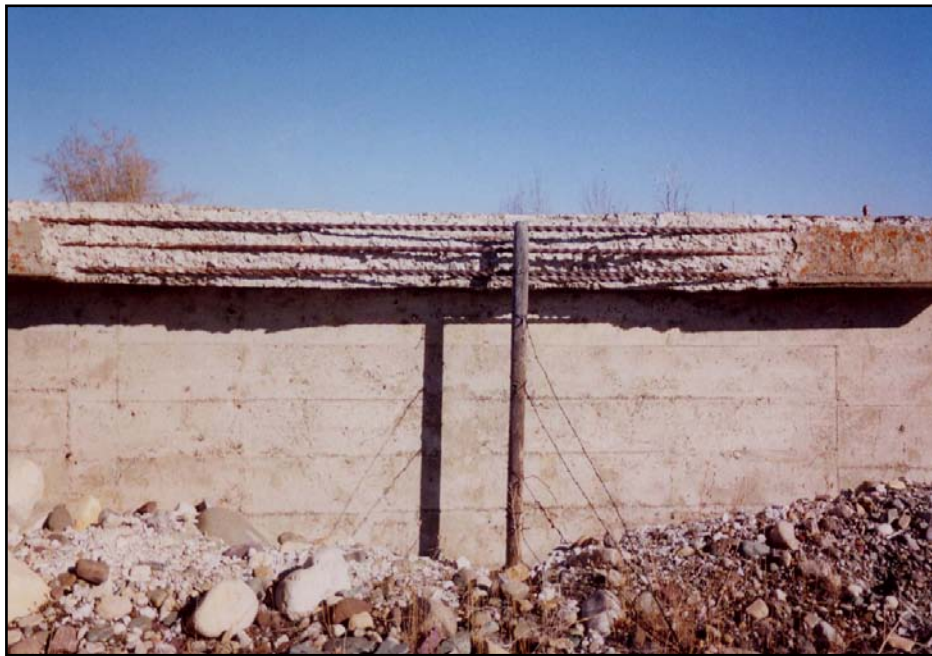
Photo 12. Kennedy Creek side of outlet transition structure. Note exposed steel reinforcement (11/11/04).

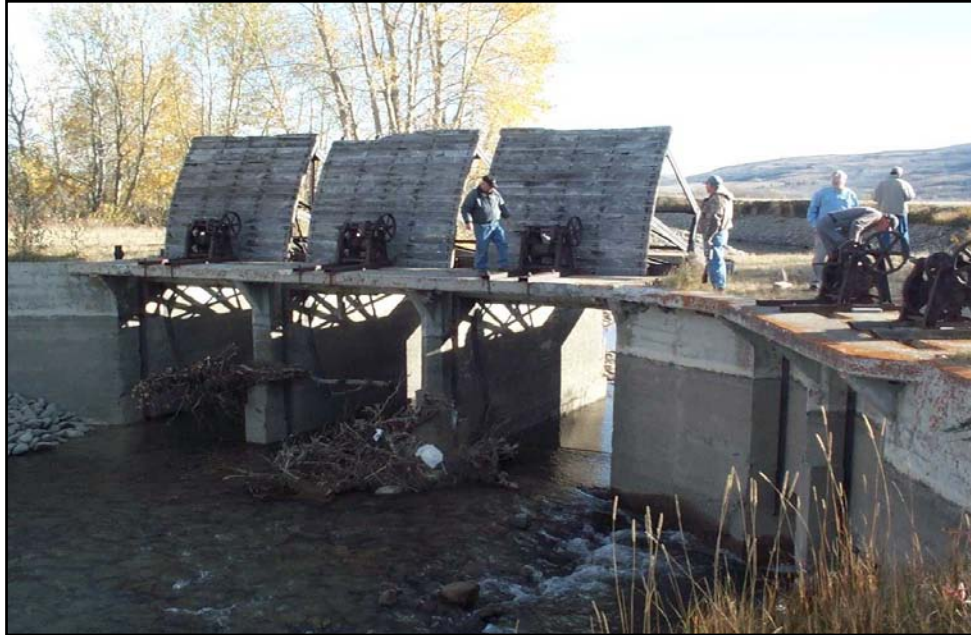
Photo 13. Upstream view of Kennedy Creek check structure during the off-season. Wasteway is located at right side of photo (10/13/04).

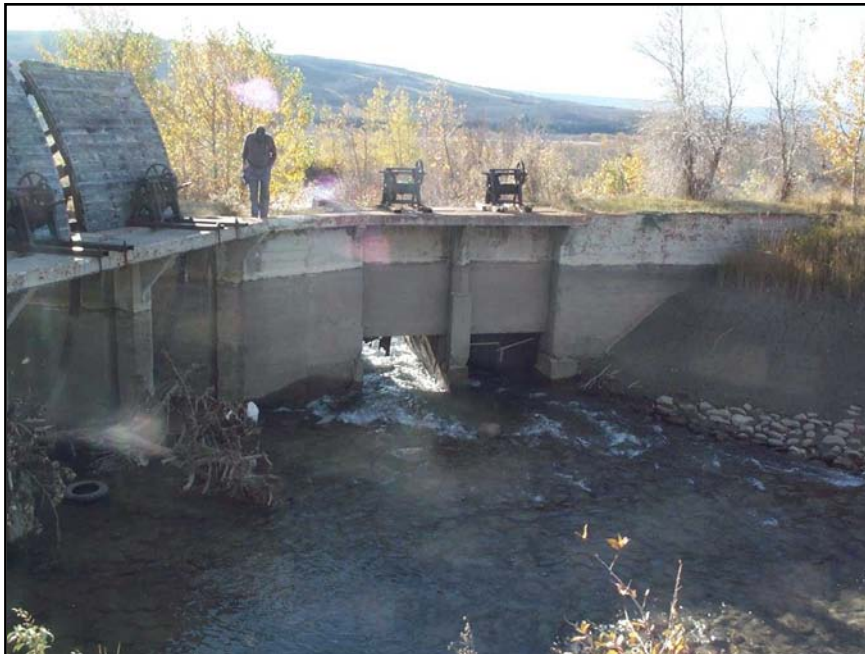
Photo 14. Upstream view of Kennedy Creek wasteway structure during off-season. Note only one gate is open. Check structure is to left. (10/13/04).

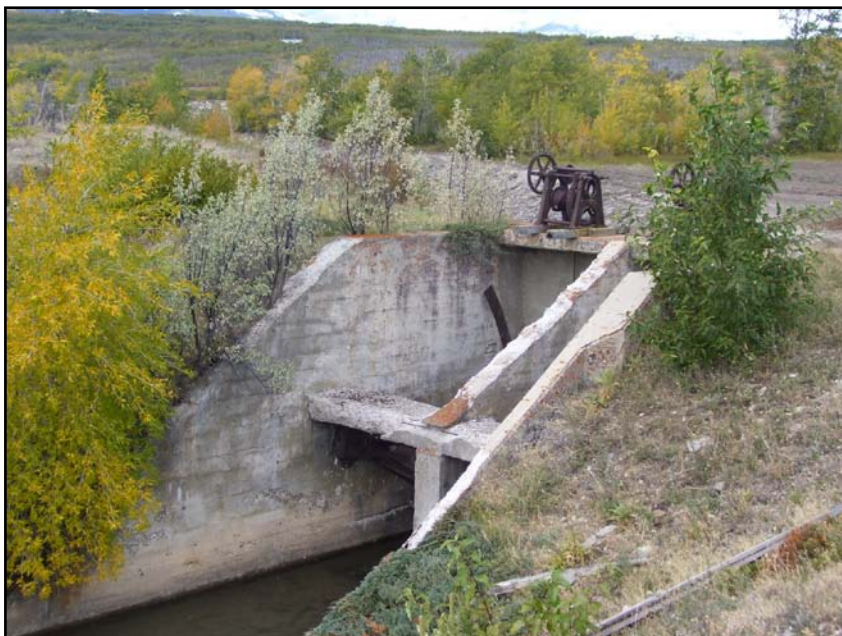
Photo 15. Downstream view of Kennedy Creek wasteway structure. Note condition of concrete surfaces (09/25/07).

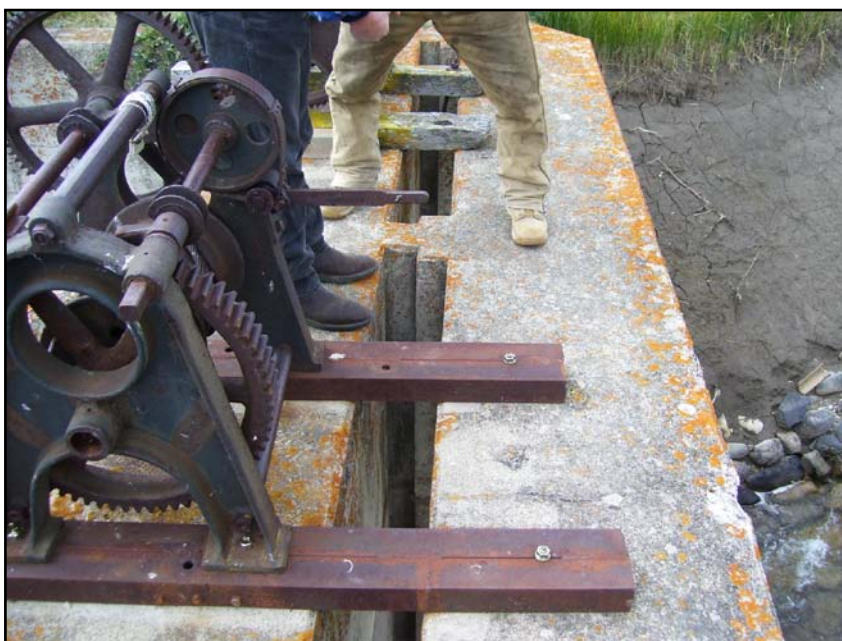
Photo 16. Kennedy Creek wasteway operators (09/25/07).

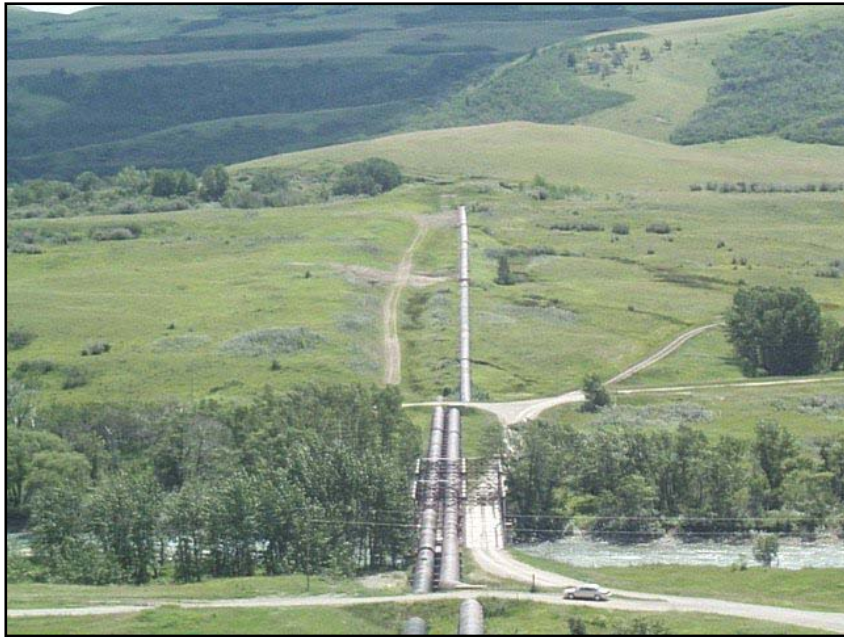
Photo 17. Looking downstream (southeast) along the St. Mary River Siphon crossing (07/04/05).

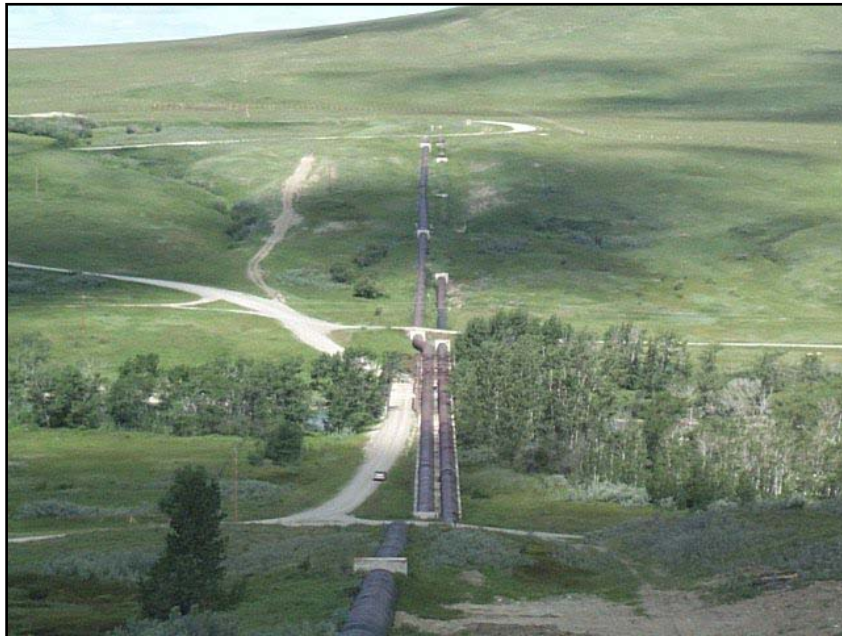
Photo 18. Looking upstream (northeast) along the St. Mary River Siphon crossing (07/04/05).

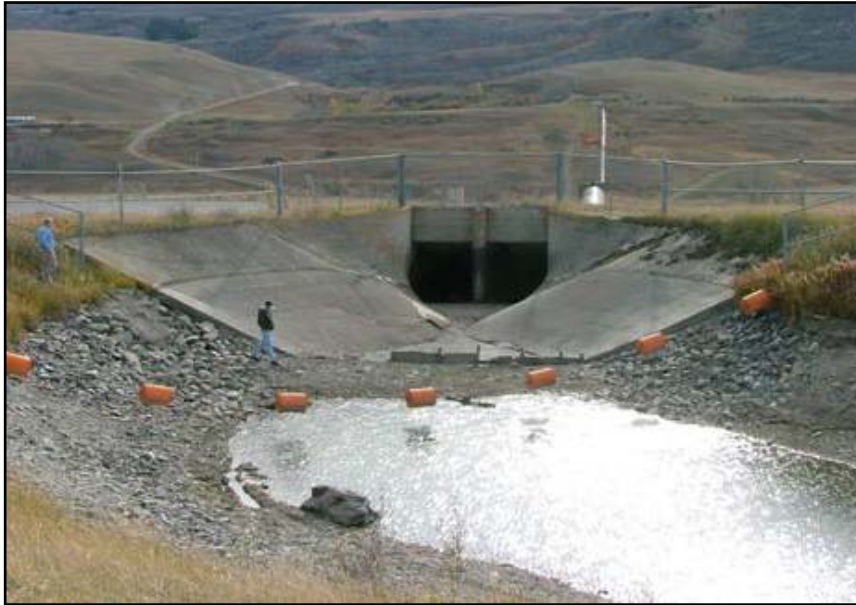
Photo 19. St. Mary River Siphon inlet structure (10/13/04).

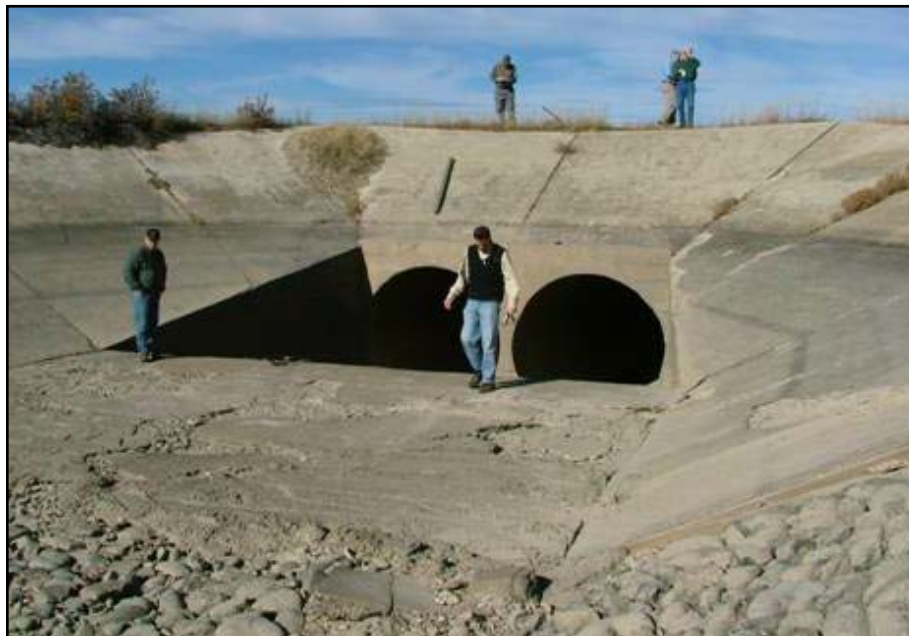
Photo 20. St. Mary River Siphon outlet structure (10/13/04).

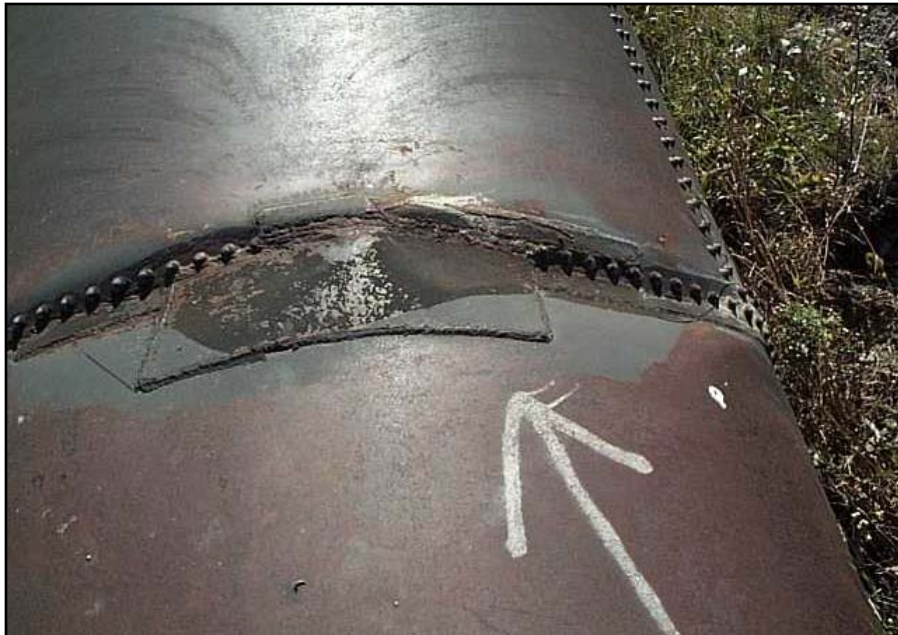
Previous St. Mary River Siphon failures have occurred due to slope movement causing compression buckling and tensional separation of the pipe at expansion/contraction joints and the concrete transition structures (Photos 21 through 23).

Photo 21. Typical siphon repair due to deflection and/or corrosion at a riveted joint. (10/13/04).

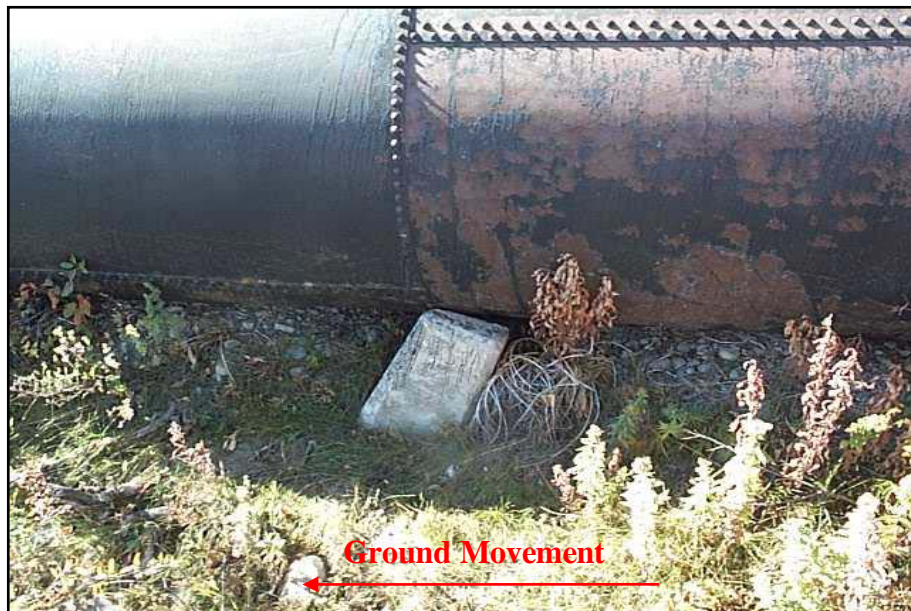
Photo 22. Photo shows ground movements right to left causing rotation of concrete support and point-loading of siphon which can lead to localized buckling (10/13/04). Photo shows the left side of the right barrel on the north slope of the St. Mary River crossing. The arrow points downhill.

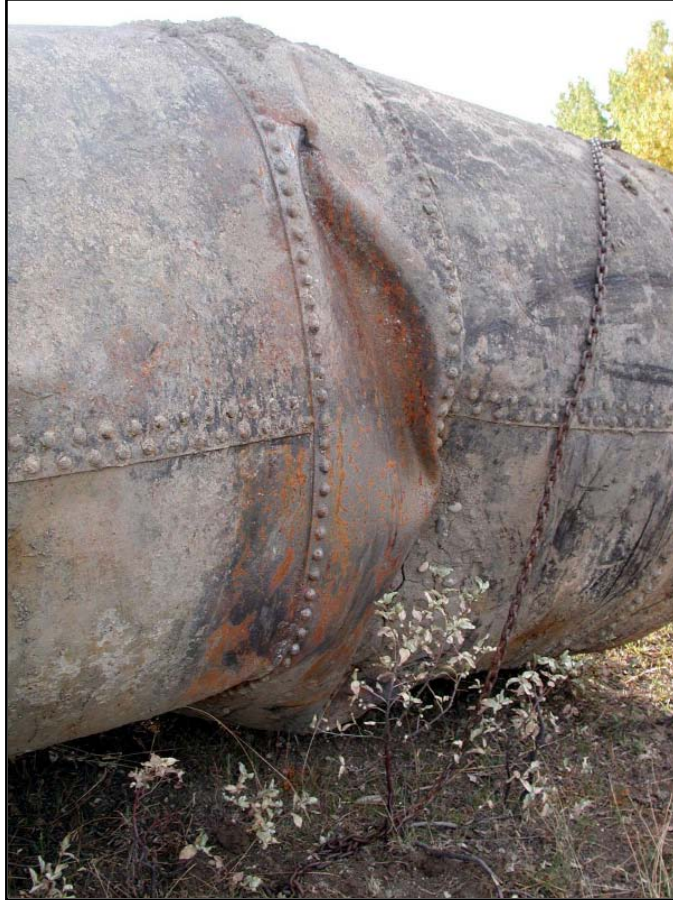
Photo 23. Photo shows buckled section of right pipe from the south slope that failed in 1996

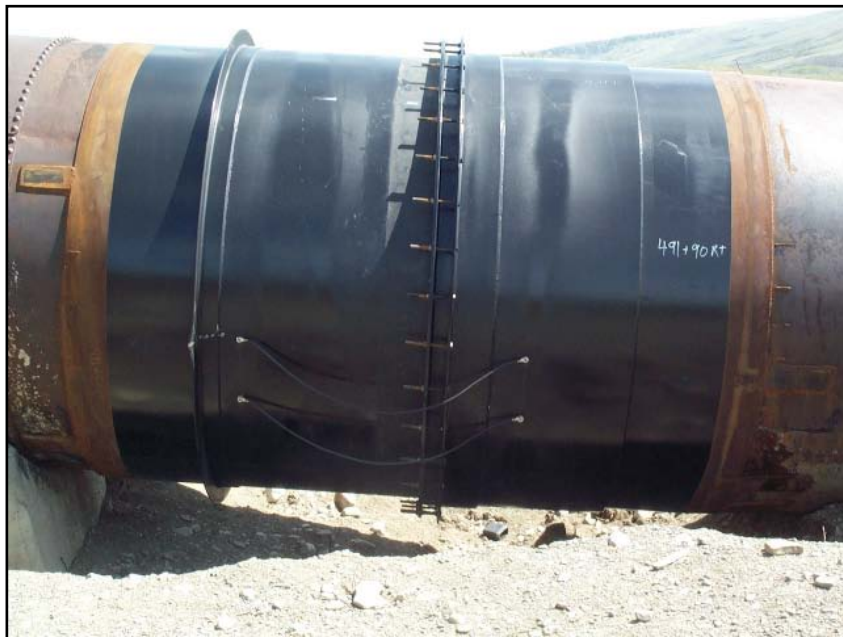
Photo 24. A typical expansion/contraction joint installed by USBR staff on the right pipe (5/16/06).

cathodic protection system, and most recently, installing additional expansion-contraction joints (Photo 24).

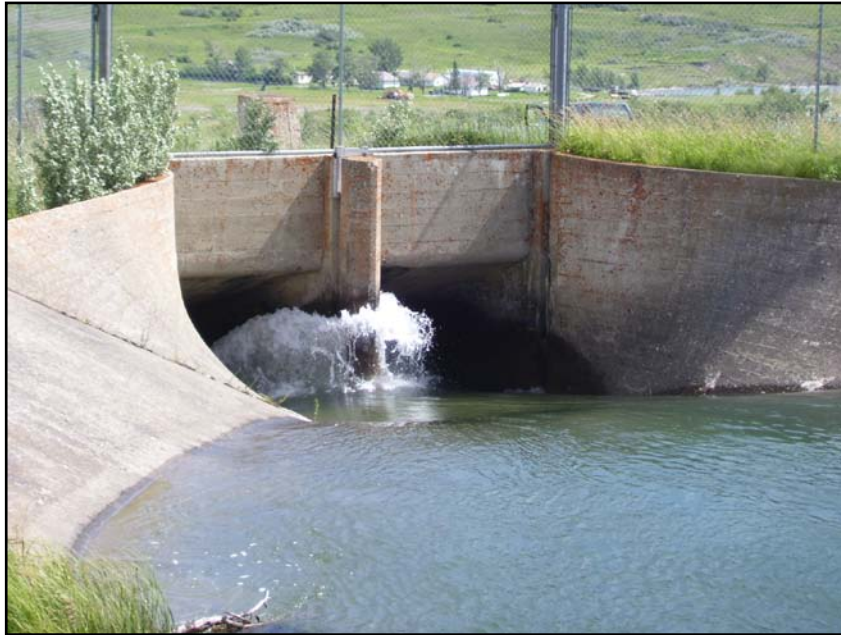
Even minor failures to a single barrel require a system shutdown to make repairs. Stop log guides exist on the inlet transition (Photo 25), but not on the outlet transition (Photo 20). Installing stop log guides and constructing stop logs for both transitions to isolate the barrel needing repairs would allow diversions to continue through the other barrel hence avoiding a complete shutdown.

Photo 25. Close-up of St. Mary River Siphon inlet during diversion. Note stop log guides in concrete (07/18/08).

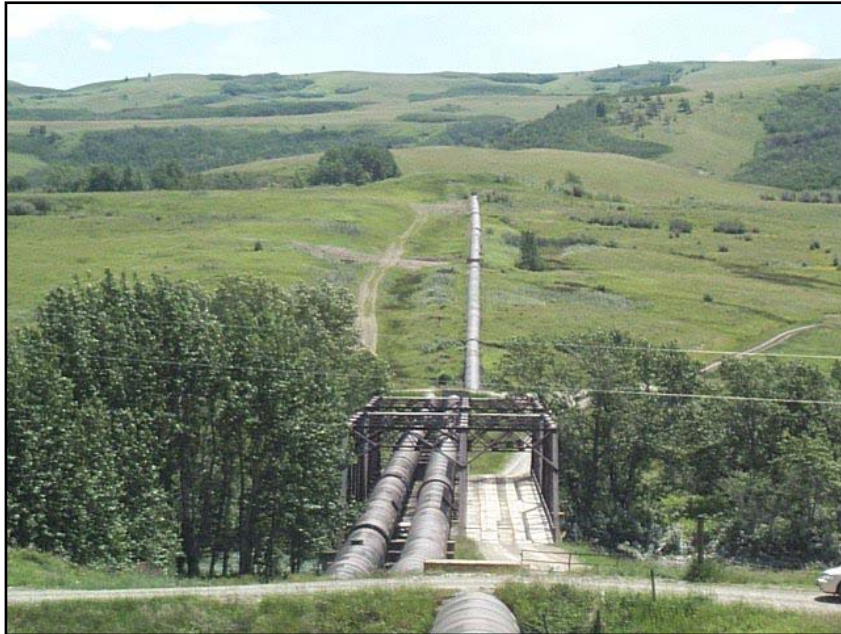
Photo 26. Looking downstream along the St. Mary River Siphon at the existing bridge (07/04/05).

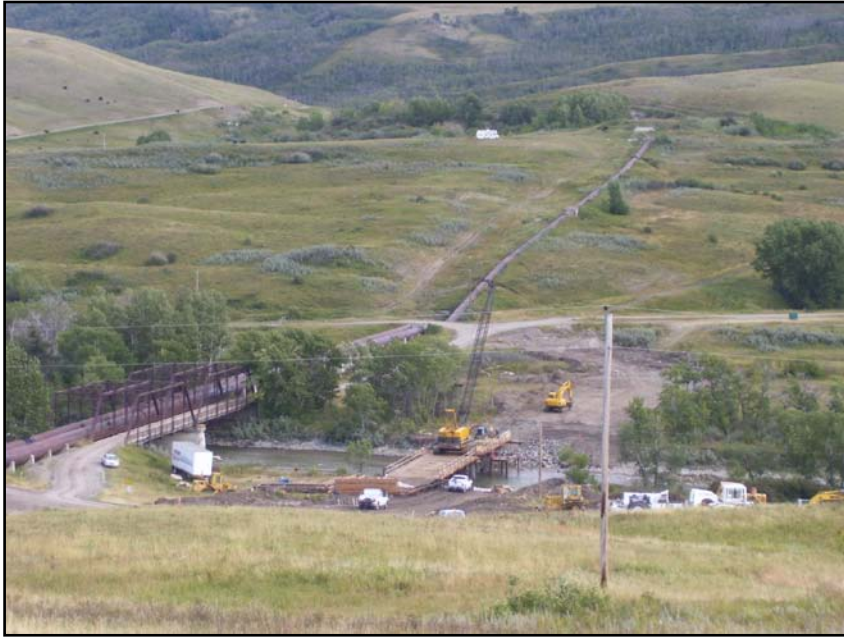
Photo 27. New Glacier County bridge under construction approximately 200 feet upstream of the existing St. Mary River Bridge (7/17/08).

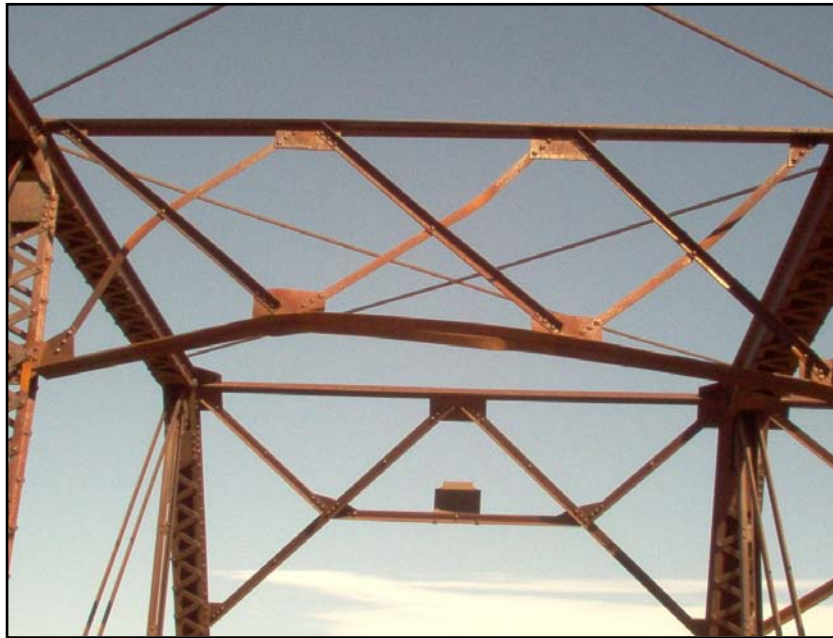
The bridge has experienced recent damage to the vertical trusses and top cords of the steel portal bracing from oversized equipment crossing the bridge (Photos 28 and 29). The posted 10-ton load limit was exceeded regularly, even when the siphon was full. The bridge is constructed of low tensile and yield strength, mild steel. The truss superstructure has a fractured critical member. The substructure exhibits deteriorating and spalling concrete, especially at the fixed bearing points. Expansion rollers are reportedly frozen and nonfunctional.

Photo 28. Damage to top chord (5/10/07).

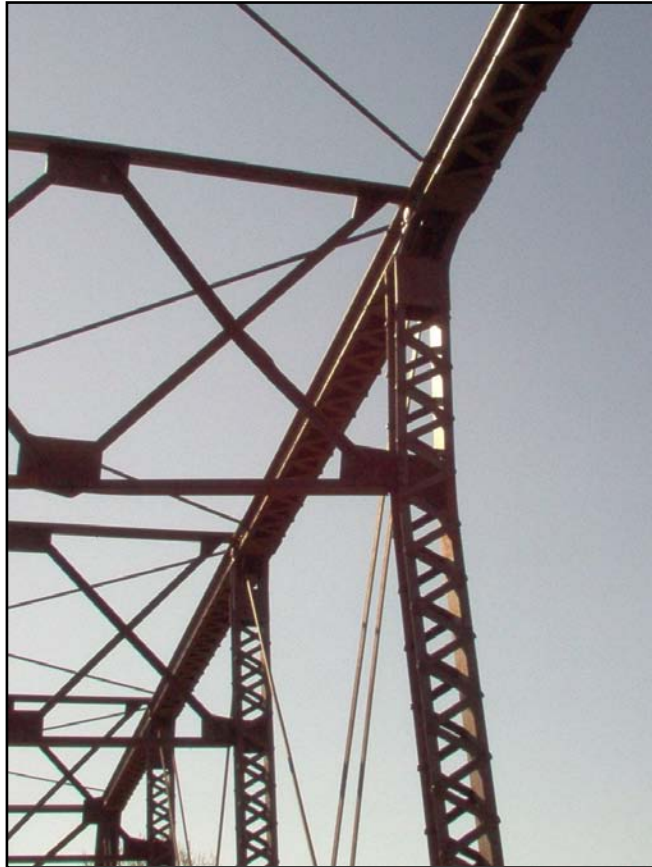
Photo 29. Damage to vertical truss (5/10/07).

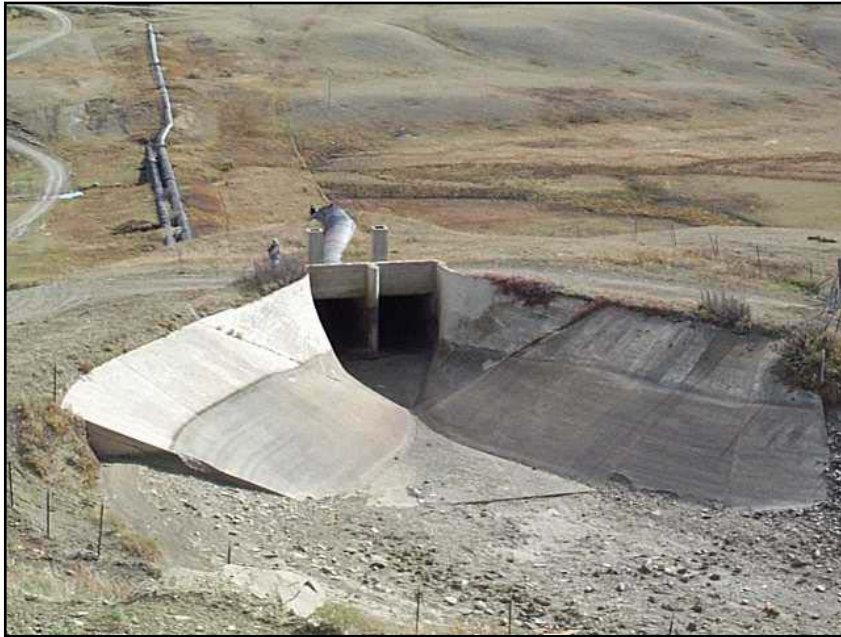
Photo 30. Looking downstream at concrete inlet transition structure for the Hall Coulee Siphon crossing (10/13/04).

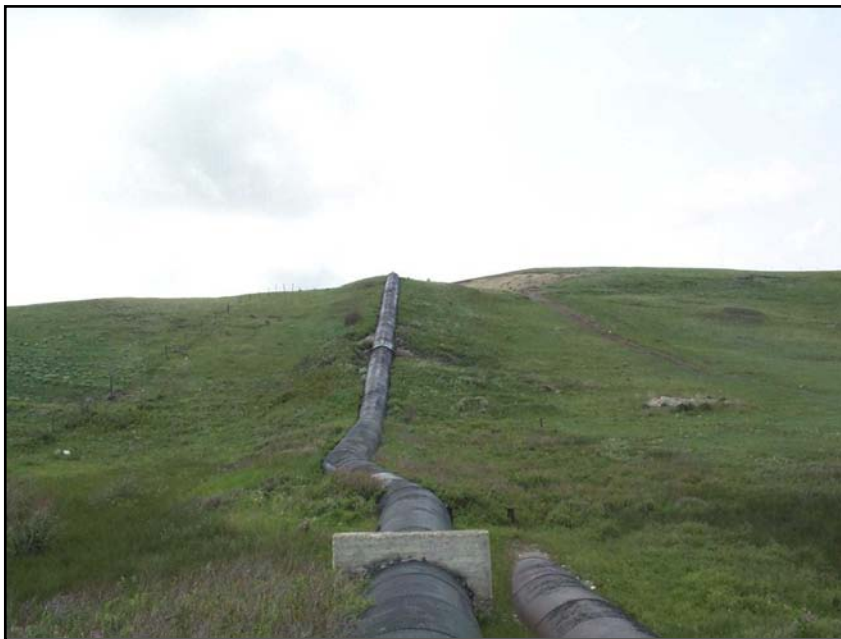
Photo 31. Looking upstream toward inlet of Hall Coulee Siphon (10/13/04).

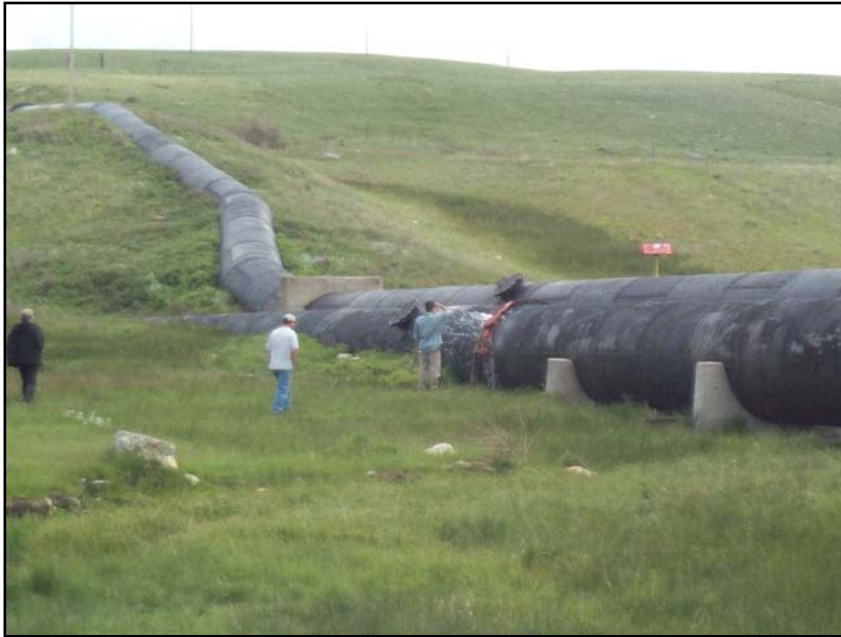
The Hall Coulee Siphon (Figure 6) was constructed in two phases with similar construction to the St. Mary River Siphon. (Photos 30 & 31). The Hall Coulee Siphon is relatively stable compared to the St. Mary River Siphon, but has experienced some minor problems with sliding, leakage and closure of expansion/contraction joints (Photo 32).

Photo 32. Looking downstream along the Hall Coulee Siphon at leaking expansion/contraction joint (06/24/04),

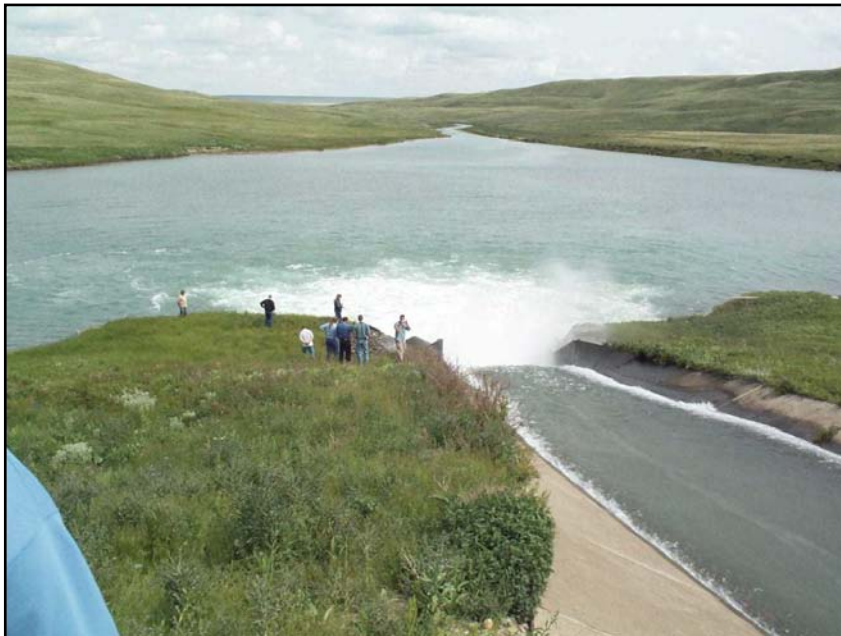
Photo 33. Looking downstream at Drop No. 1 chute and stilling basin (06/24/04),

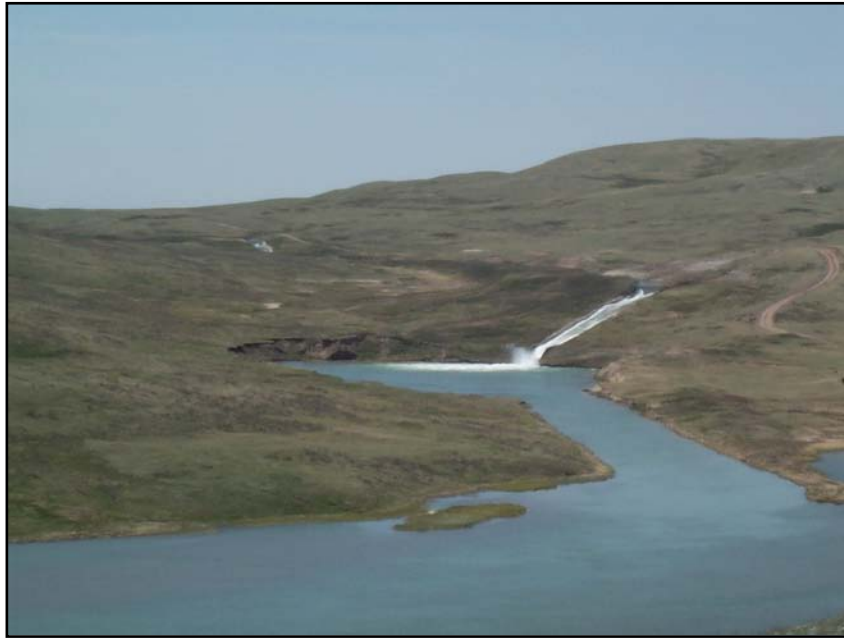
Photo 34. Looking upstream towards Drop No. 2 (05/16/06),

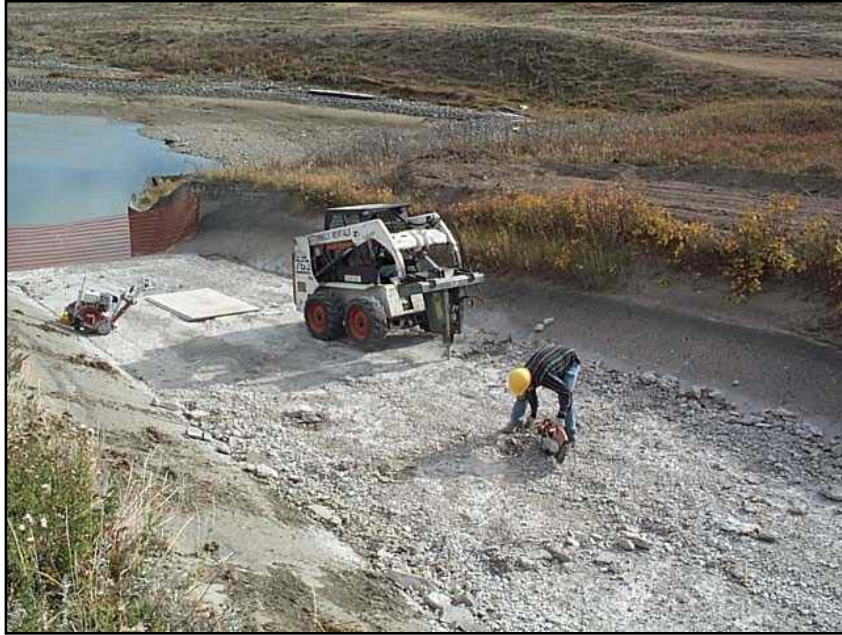
Photo 35. Repairs being made to chute floor of Drop No. 3 during off-season (10/13/04).

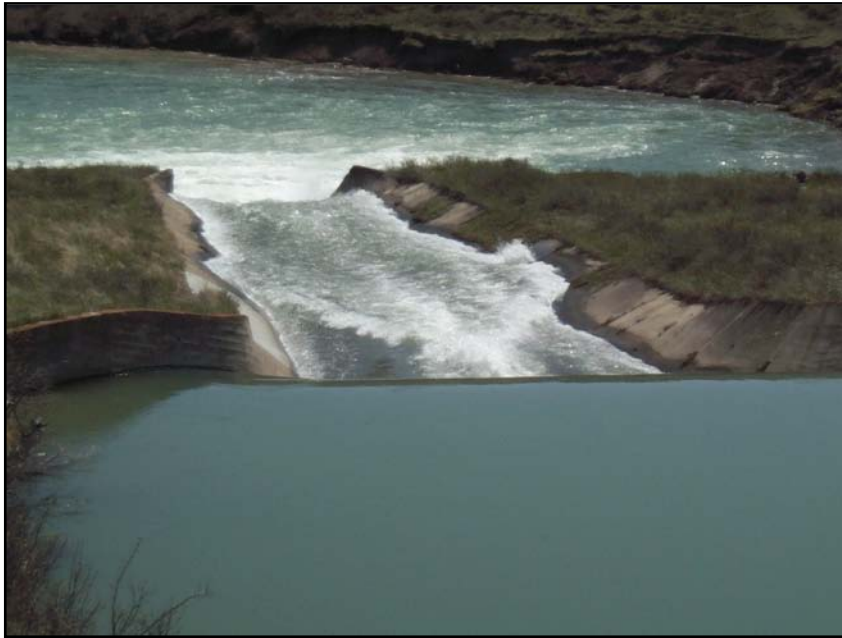
Photo 36. Looking downstream at Drop No. 2 during diversion. Note dramatic change in flow regime. Also see Photo 37 (05/16/06)

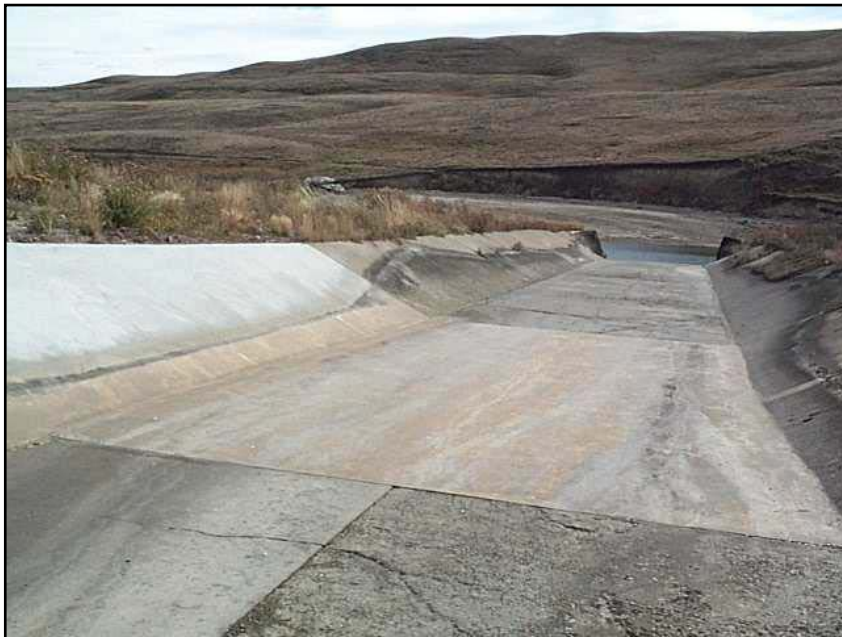
Photo 37. Drop No. 2 in the off-season. Note clean flow lines over new concrete surfaces replaced in 2002 and increased flow depth over rougher, older concrete surfaces (10/13/04).
