ST. MARY DIVERSION and CONVEYANCE FACILITIES

Failure and O&M Reference Guide

January 2010 (Final)

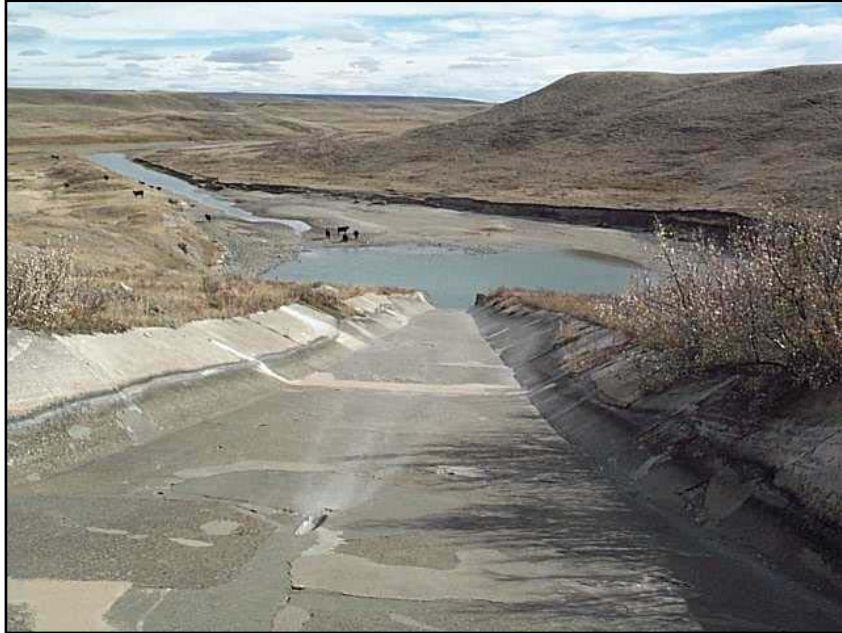
Photos 38 and 39 also show deteriorating flow regimes and potential chute jumping. This is evident from the staining on the chute sidewalls. Loss of containment associated with chute jumping, combined with the steep terrain and erodible soils, could result in progressive backside erosion and sidewall collapse.

Photo 38. Downstream view of Drop No. 4. Note irregular flow regime and potential chute jumping as evident from the concrete staining (10/13/04).

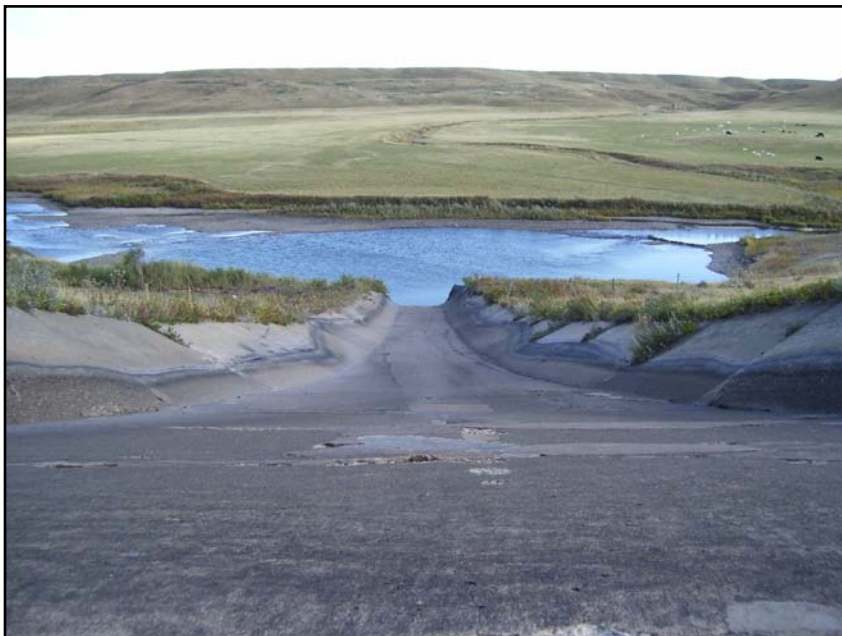
Photo 39. Downstream view of Drop No. 5. Note irregular flow regime and potential chute jumping as evident from the concrete staining (09/27/07).

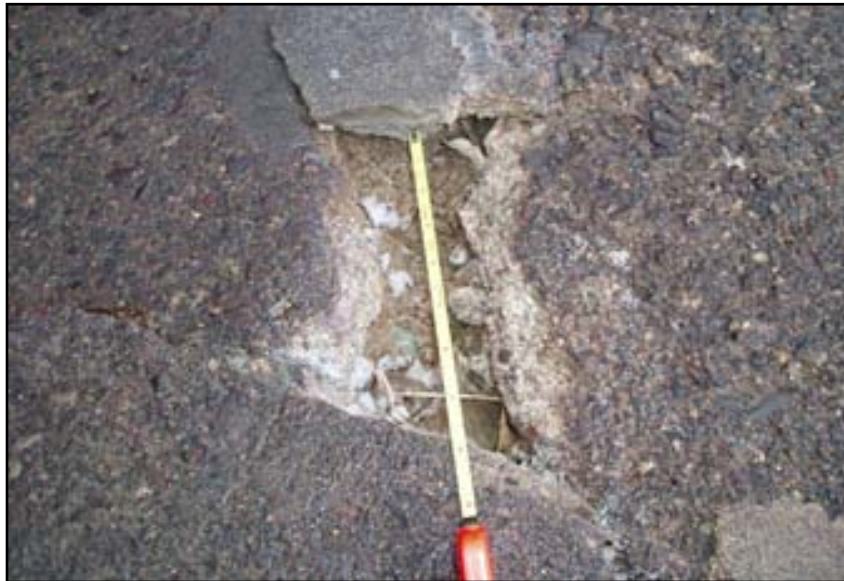
Photo 40. Close-up of concrete deterioration of Drop No. 4 chute floor (11/10/04).

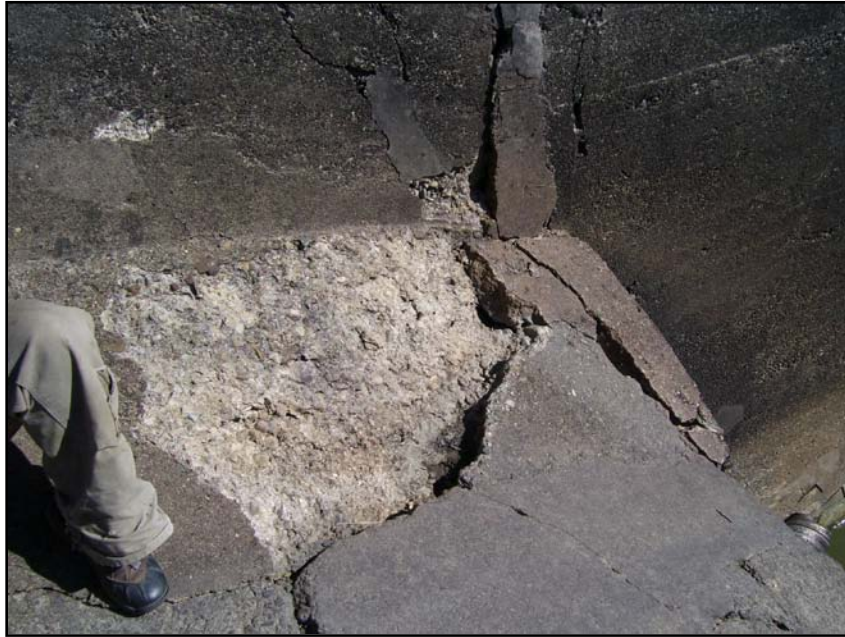
Photo 41. View of chute floor directly above plunge pool headwall of Drop No. 2. Note the degree of concrete ablation (09/27/07).

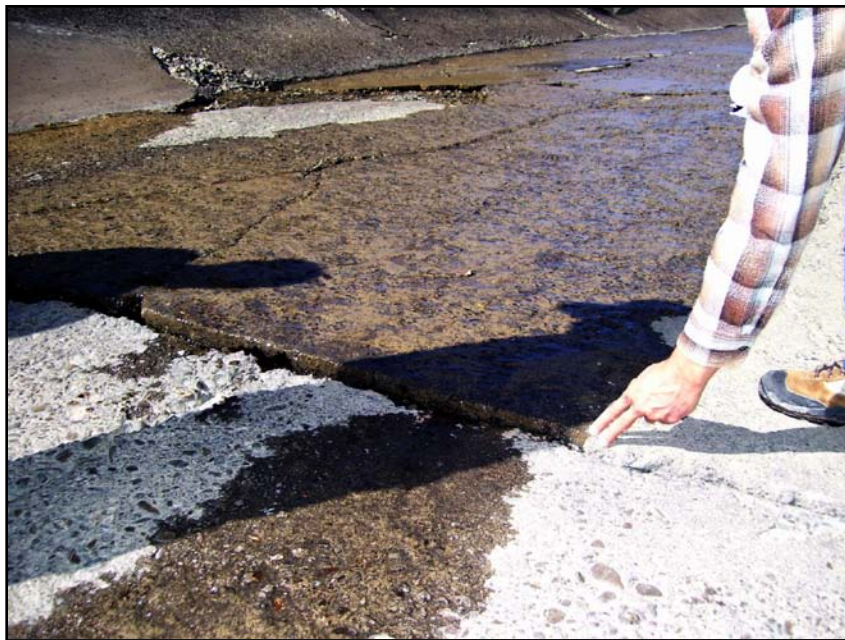
Photo 42. View of slab offset in chute floor of Drop No. 2. (09/27/07).

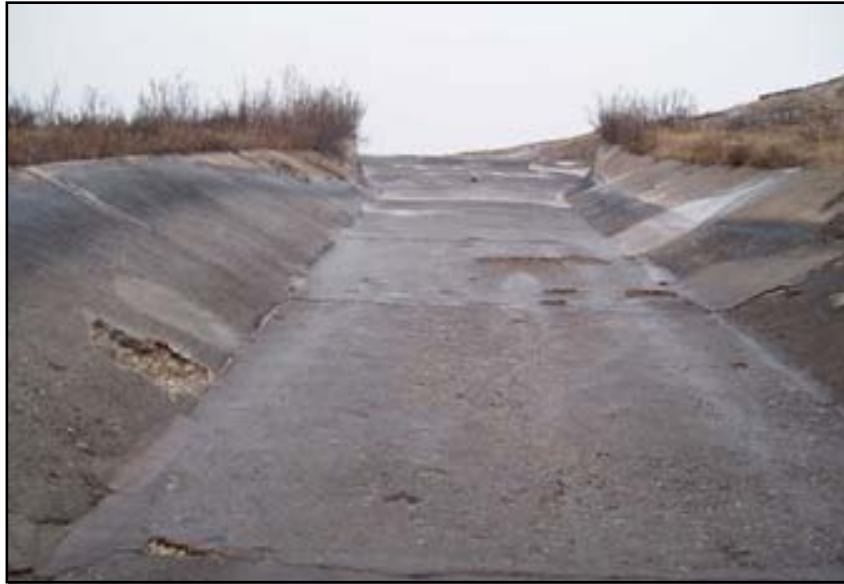
Photo 43. Close-up of concrete deterioration of Drop No. 4 chute floor (11/10/04).

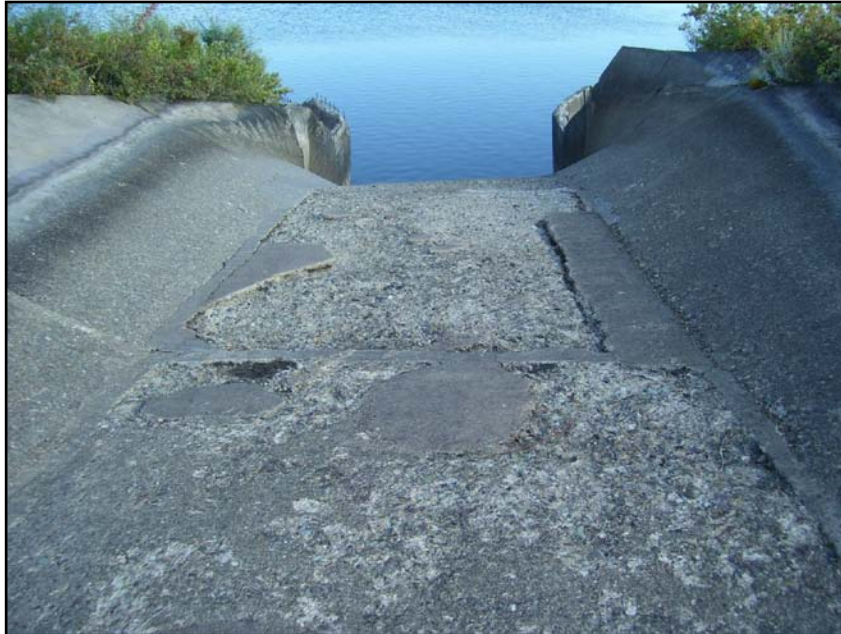
Photo 44. Looking downstream at lower end of chute floor for Drop No. 5. Note condition and surface roughness of concrete (09/27/07).

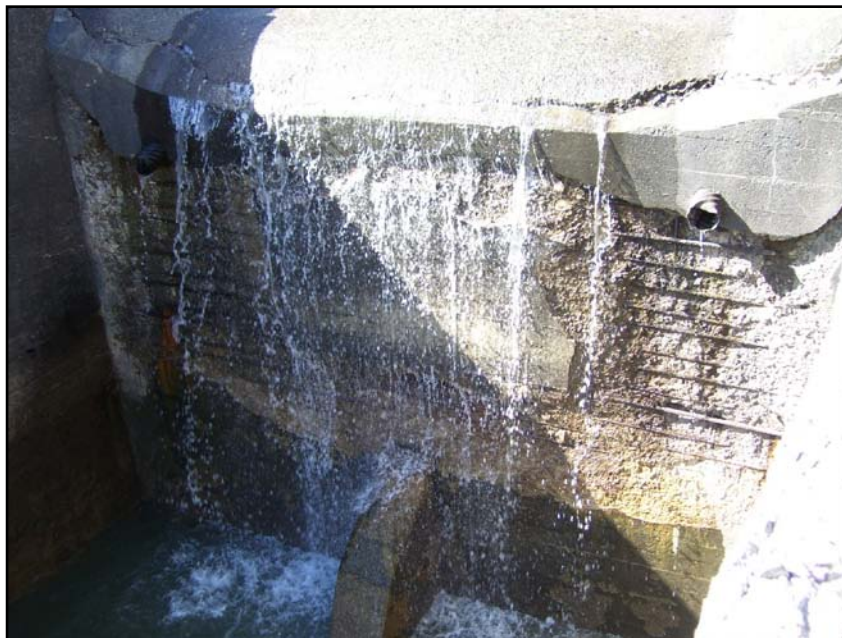
Photo 45. View of plunge pool headwall of Drop No. 1. Note condition of concrete and exposed reinforcement steel (09/27/07).

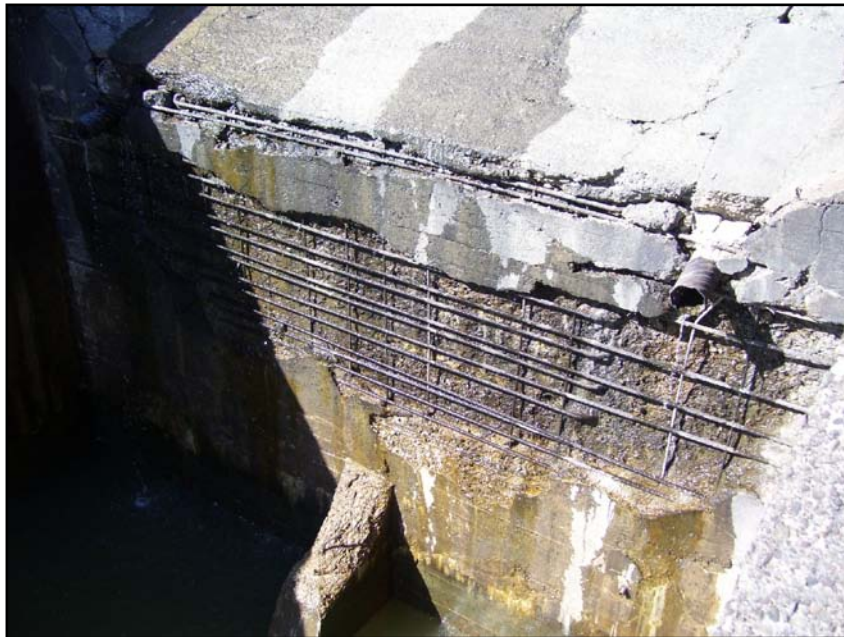
Photo 46. View of plunge pool headwall of Drop No. 2. Note condition of concrete and exposed rebar (09/27/07).

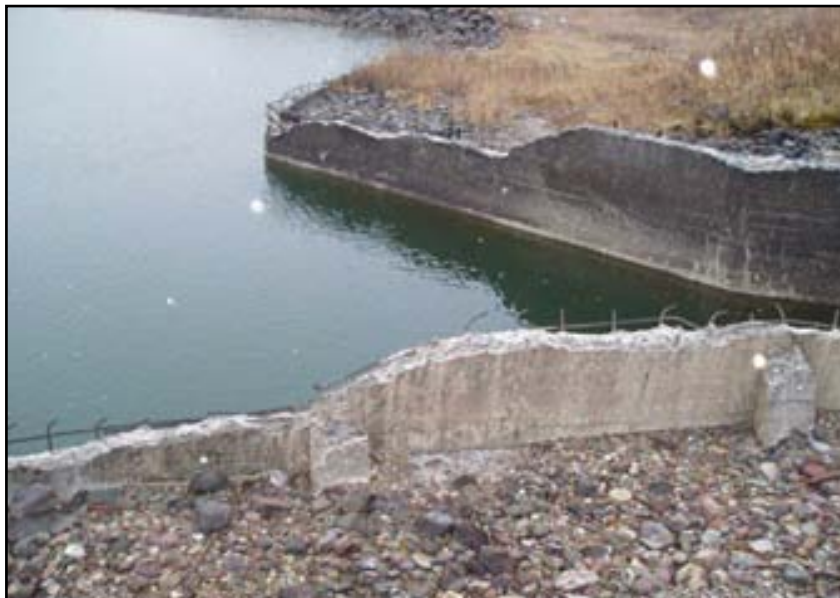
Photo 47. Heavily damaged/eroded wing and training walls on Drop No. 5 (11/10/04).

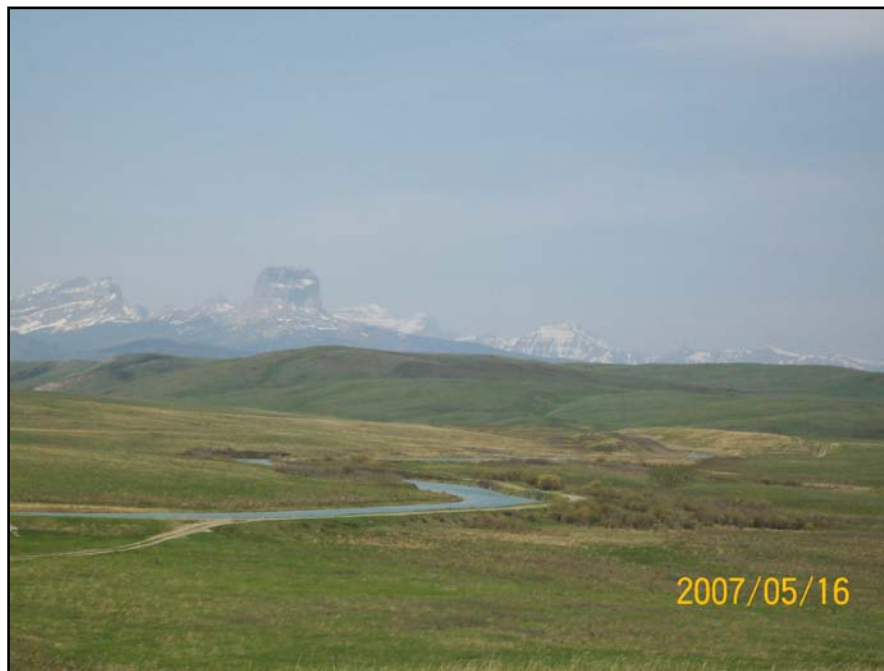
Photo 48. Canal, looking upstream toward Big Cut Slide. Note winding, contour-following nature of the canal alignment. (05/16/07).
