St. Mary Canal

System Improvement Plan

November 23, 2022

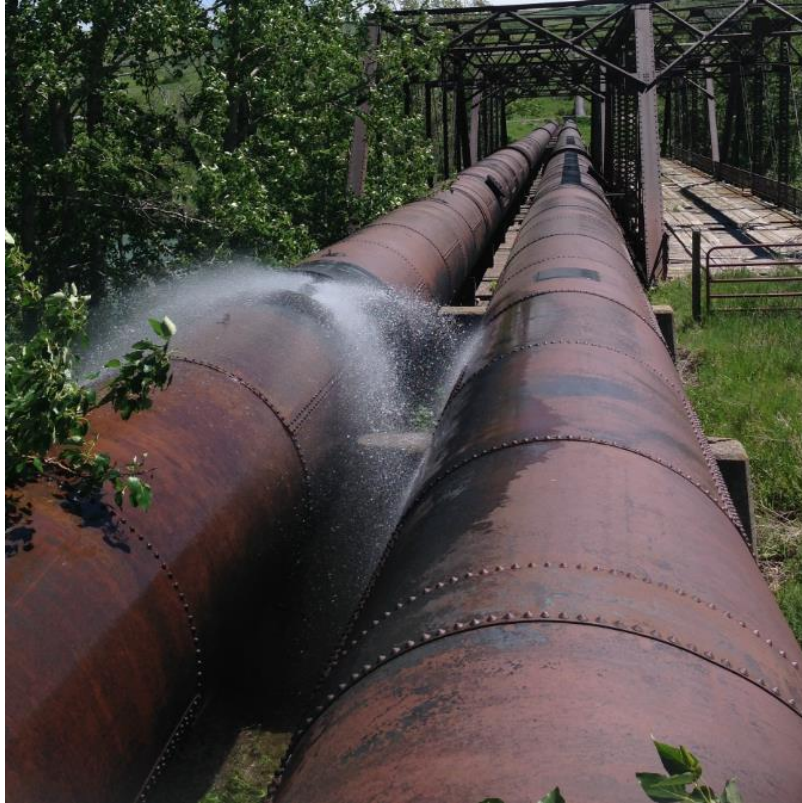
Figure 2-3. St. Mary Siphon Leaking Steel Barrels

During the irrigation season, while the Canal system is in operation, there are visible leaks in the steel barrels (Figure 2-3 and Figure 2-4).

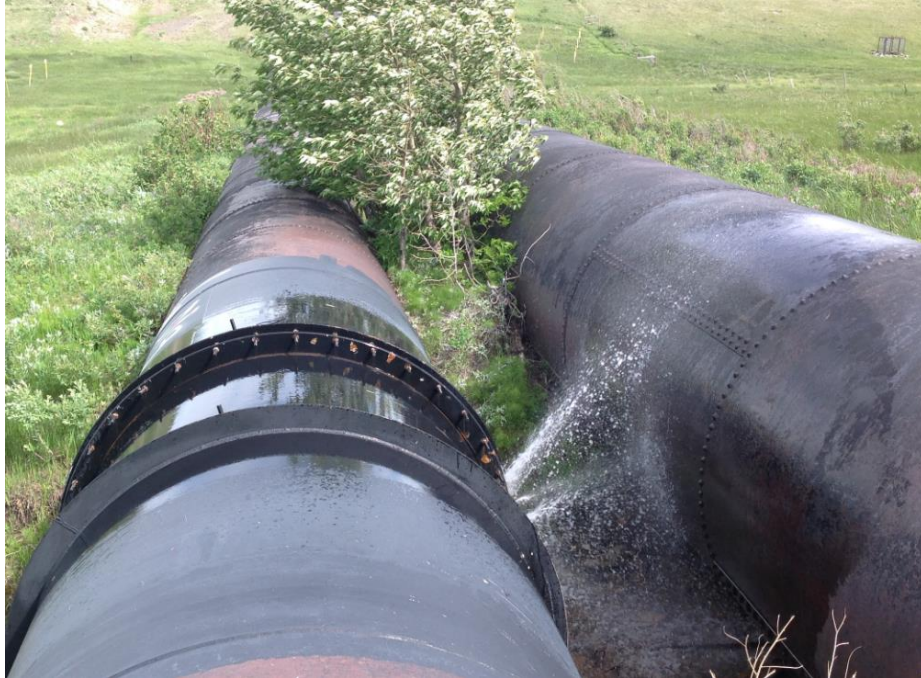
Figure 2-5. Halls Coulee Barrel Leak

The Halls Coulee Siphon crosses a broad valley about 8 miles downstream of the St. Mary River Siphon. It has two riveted steel barrels, 6.5 feet in diameter and 1,405 feet in length, with concrete saddle supports. The maximum head on the Siphons is 102 feet. The twin barrels have a combined capacity of 850 cfs. Corrosion and weakened concrete saddle supports are visible along the reach of both barrels. Leaking barrels are also evident during the irrigation season (Figure 2-5 and Figure 2-6).

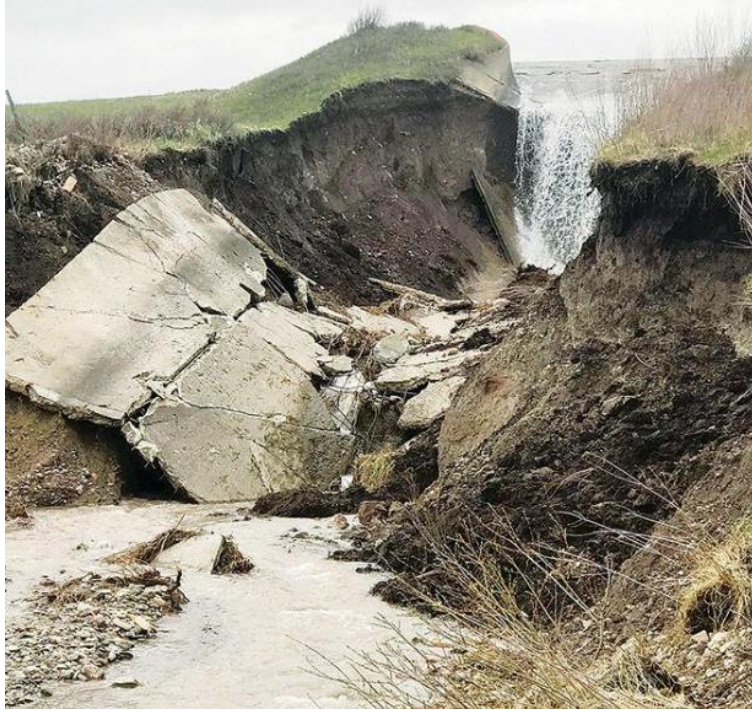
Figure 2-10. Drop 5 Failure on May 17, 2020³

All five drop structures are reinforced concrete chutes with plunge pools/stilling basins at the bottom and are designed to convey 850 cfs. The drop structures were constructed between 1912 and 1915. Drops 2 and 5 were replaced in 2020 after the catastrophic failure of Drop 5 on May 17, 2020. See Figure 2-10.

According to the Geotechnical Engineering Report (Terracon, 2020), the Drop 5 failure was likely caused by internal erosion of dispersive materials within the structure subgrade. The failure event was observed to have eroded the structure subgrade to maximum depths approximately 25 feet just downslope of the entry weir crest, and to widths as narrow as 10 feet but up to 20 feet in width. Subsequent observations of the structure site also indicate that the subgrade erosion likely precipitated tilting of the floor slabs within the drop structure. Then further erosion and piping ultimately caused the drop structure to become undermined, resulting in the damage to the structure by tilting of the structure slabs and subsequent damage to the drop structure caused by water flow damage.

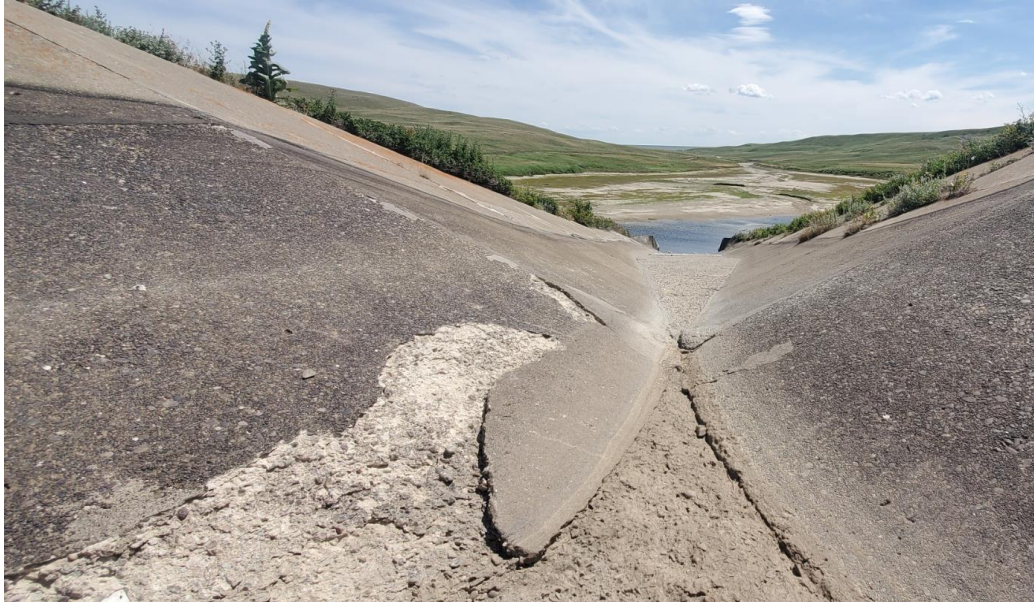
Figure 2-11. Drop 1 Chute Condition

Currently, Drops 1, 3 and 4 show noticeable signs of chute sidewall and slab deterioration, wingwall settlement, exposed rebar throughout, and cracking and spalling

concrete evident along the chutes, chute sidewalls, wingwalls, and plunge pool walls of each structure. See Figure 2-11, Figure 2-12, & Figure 2-13 below.

The concrete floor of Drop #1's stilling basin is in poor condition, with exposed rebar in various locations and in one location the damage has worn through the first mat of rebar and is beginning to degrade the second mat.

The terminal wall has significant concrete damage, with exposed rebar along the majority of the wall and holes that have extended into and past the second mat of rebar. It doesn't appear that the holes go all the way through to the backfill material, but it could happen in the near future and start to erode backfill material that is not only holding up the wall but also the chute.

Due to the age, existing condition, recent 2020 failure of Drop 5 and available literature reviewed for the drop structures, a replacement in-kind is recommended for Drops 1, 3 and 4 with minor variations in cross section and overall layout to improve capacity, flow characteristics, and structure durability. The 10% design for these in-kind replacements is provided in Appendix C. The replacement drops final design will likely be similar to the Drop 2 and Drop 5 structures constructed in 2020.

The cross section of the replacement chute would be rectangular, instead of trapezoidal to better contain the flow and prevent overtopping of the sides. In addition, the sidewalls at the approach to the chute would be vertical, in place of the current, convoluted transition and warping sidewalls.

Severe deterioration within the existing plunge pools has occurred over time as a result of the impact of falling water, improper ventilation, cavitation and freeze-thaw damage. Protective measures should also be implemented to prolong the life of the concrete, specifically within the plunge pool, including a thicker concrete slab, ventilation, and air-entrained concrete which is more suitable for the harsh freezing conditions realized in this geographic region.

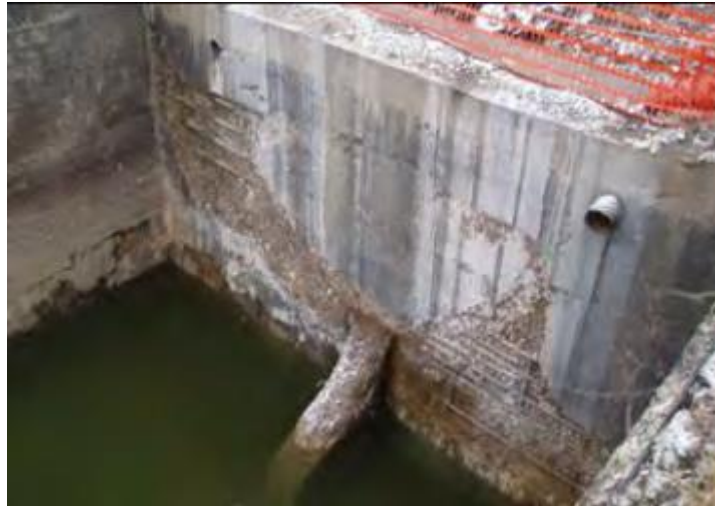
Figure 2-12. Drop 3 Plunge Pool Headwall Condition

The terminal wall has major cracking and spalling, and due to the nature of the cracking, is broken into separate blocks of concrete rather than one solid wall. The left wingwall has a large bulge and crack in the wall about 1/3 up from the bottom. It is assumed that the pressure being exerted on the wall from the fully saturated soils behind the wall and lack of weep holes in this section is causing the bulge and the wall is largely being held together by the rebar. Some repairs have been made to Drop 4 including stabilization of the right wingwall and the filling in of a large hole downstream of the stilling basin that was approximately 50 deep wide, 70 feet long and 8-10 feet deep.

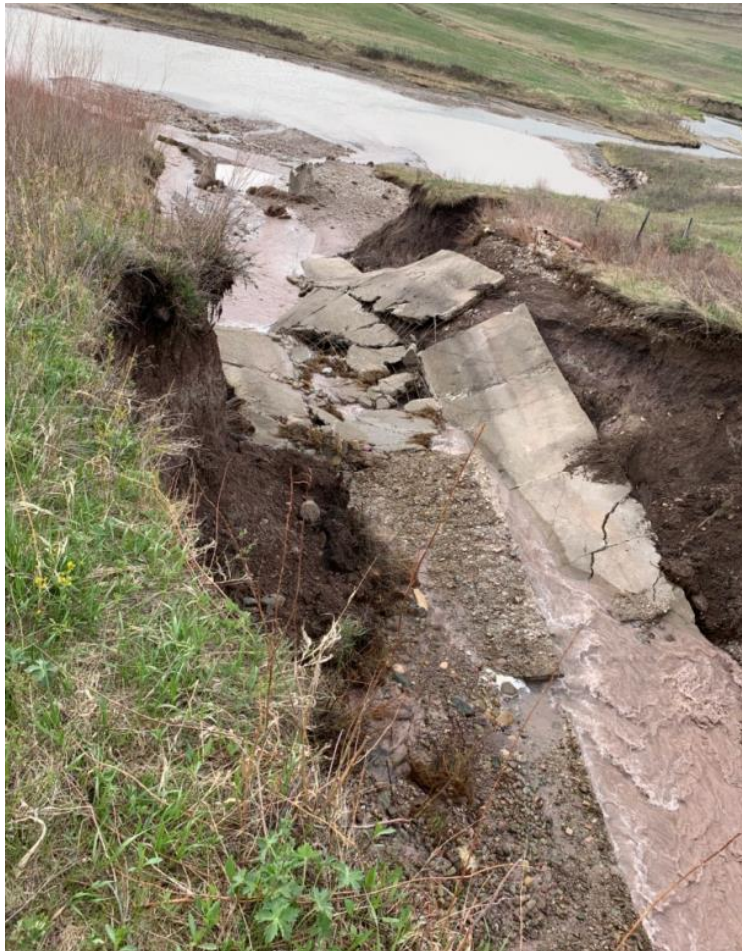
Figure 3-5. Drop 5 Failure¹¹

Shortly after the Drop 5 failure, the MRJBOC, Reclamation and Montana DNRC conducted an engineering site inspection to assess the damage and determine whether an interim fix was feasible. The team concluded that the complexities and costs associated with an interim solution could not be justified, considering the anticipated
