ST. MARY DIVERSION and CONVEYANCE FACILITIES

Failure and O&M Reference Guide

January 2010 (Final)

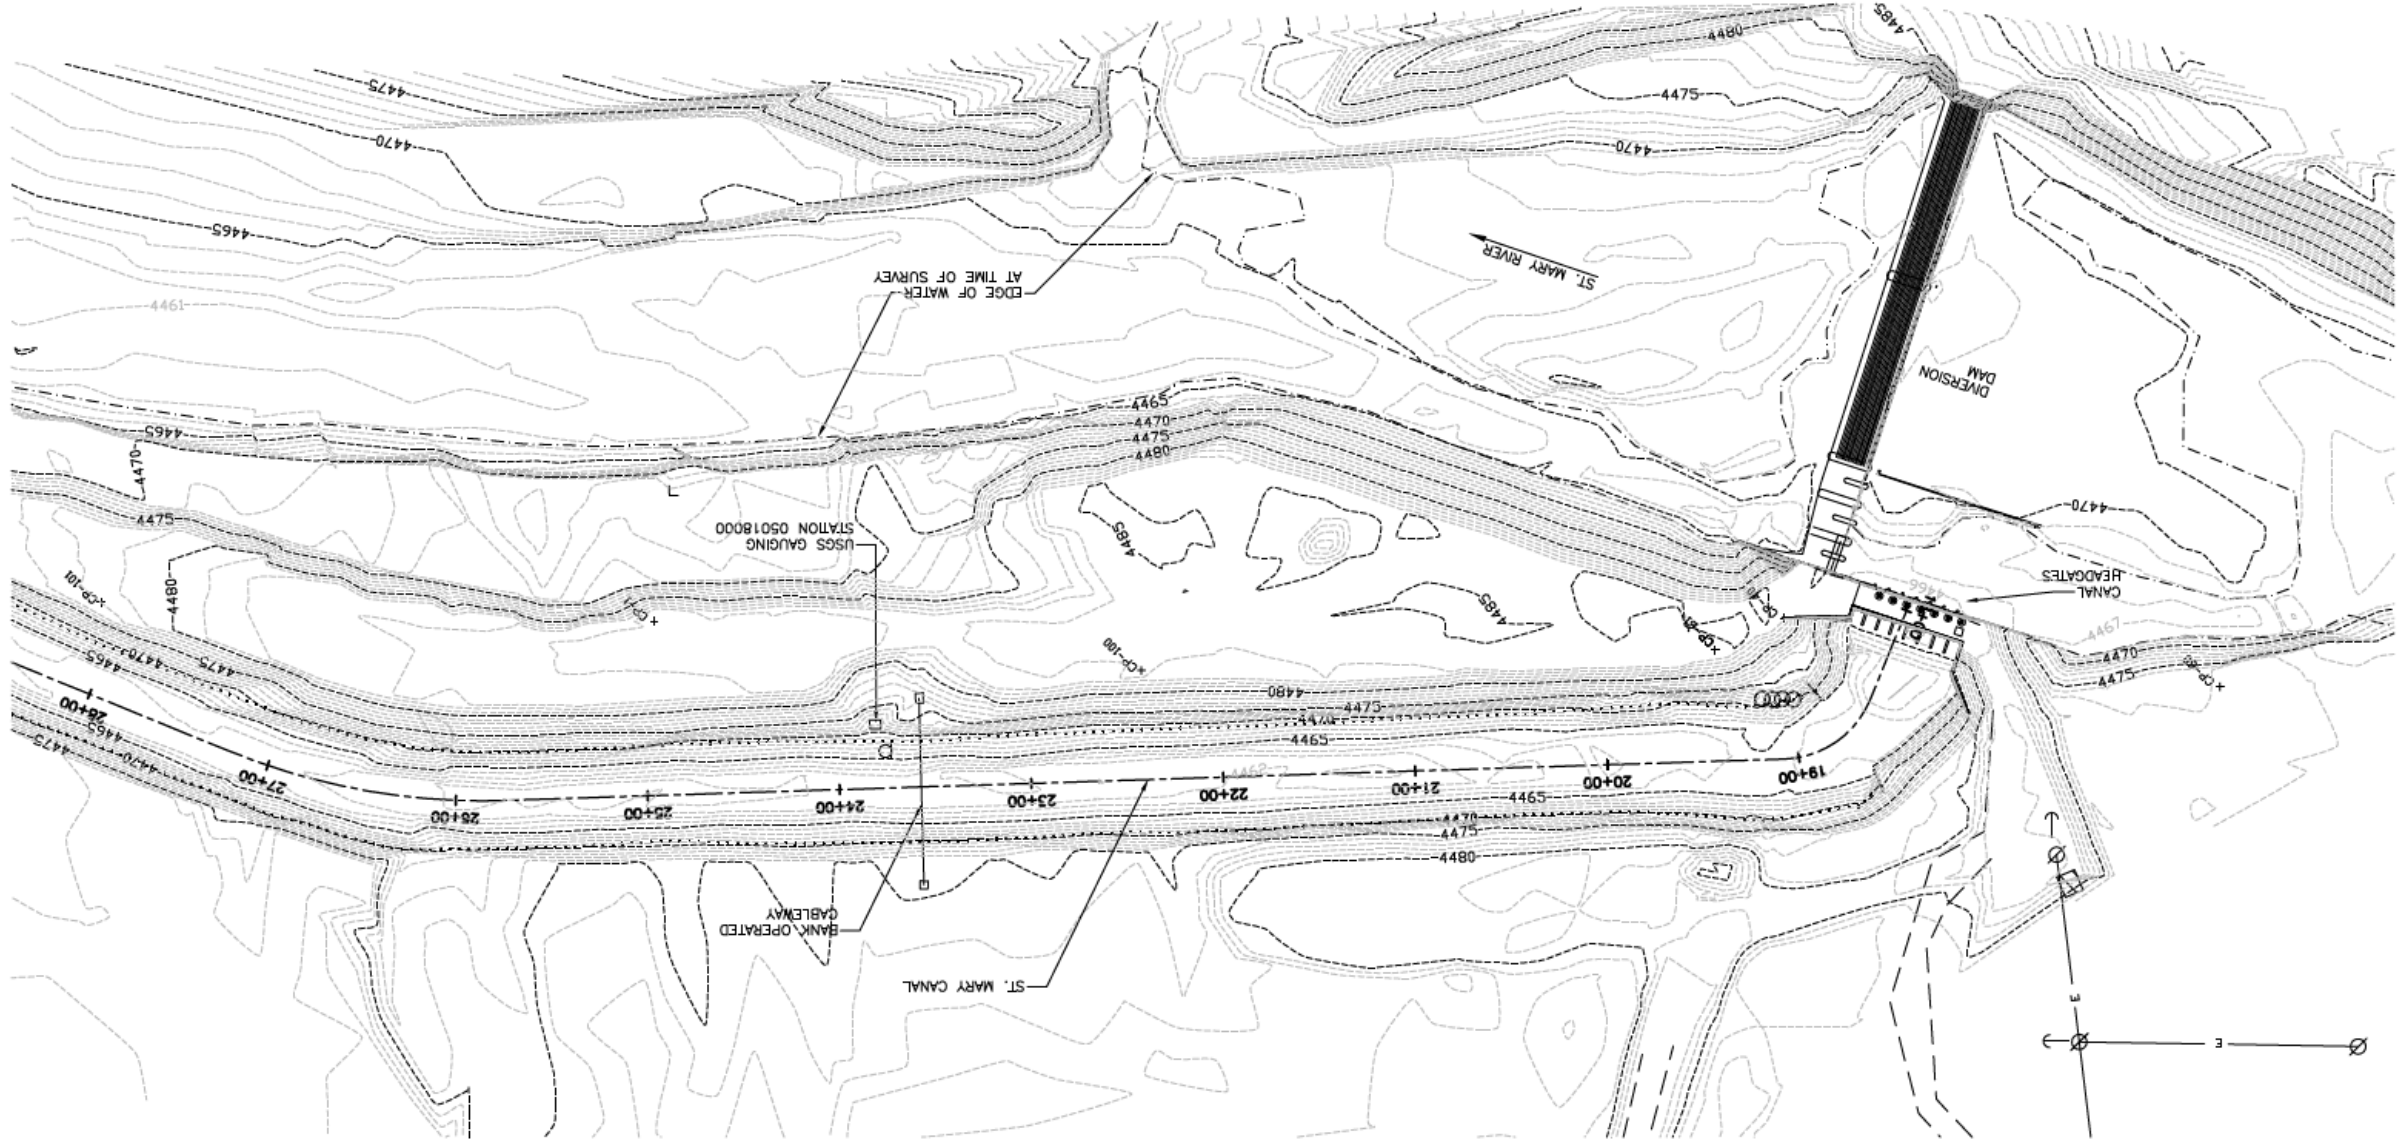
FIGURE 1

The existing diversion dam (Figures 1 and 8) is a sharp-crested, concrete, overflow dam (See Photo 1). The eastern portion of the dam has a crest length of 190 feet. The western portion of

SHEET 1 OF 1
 CAD NO. 04167-872.DWG
DNRC - WATER RESOURCES DIVISION
ST. MARY DIVERSION FACILITIES
EXISTING DIVERSION DAM AND CANAL HEADGATES

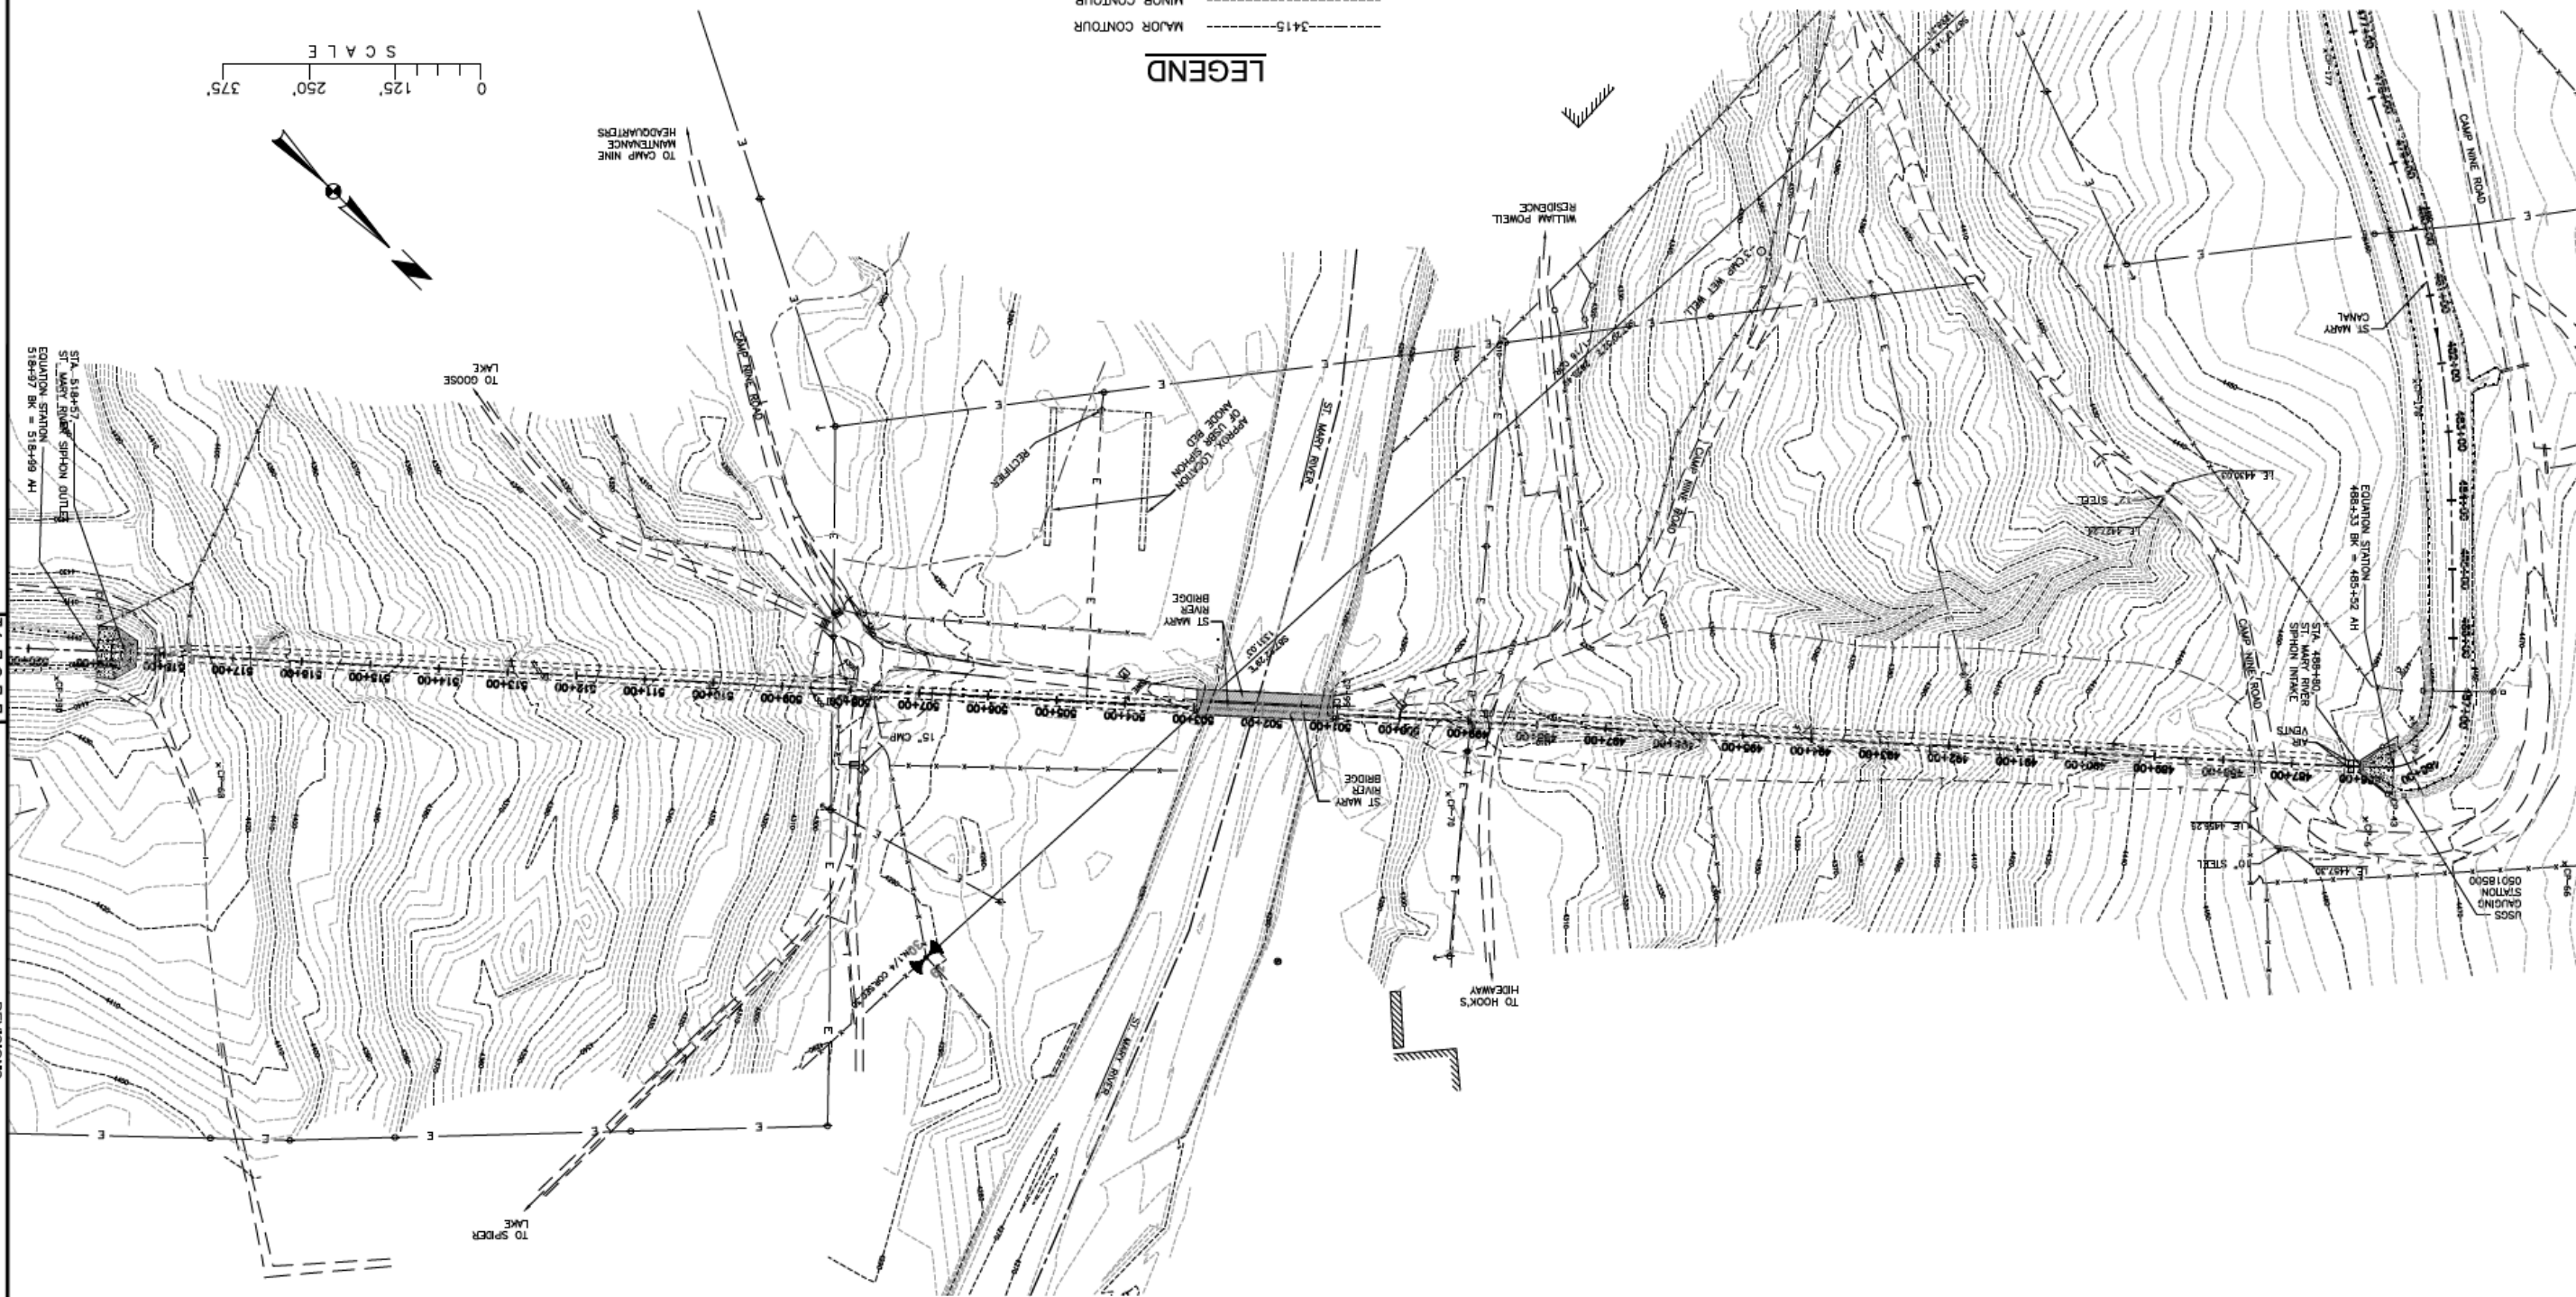
FIGURE 4

The St. Mary River Siphon is the most significant feature of the St. Mary River Diversion and Conveyance Facilities (Figures 4 and 8). The 3,260-foot long inverted siphon consists of two riveted steel pipes ranging in diameter from 84 to 90 inches (See Photos 17 and 18). The discharge capacity of each pipe is 425 cfs for a combined capacity of 850 cfs. The maximum static head is 165 feet (71.5 psi) which is the approximate elevation difference between the siphon inlet and the bridge crossing. The siphon inlet and outlet are concrete transition structures (Photos 19 and 20).

Previous St. Mary River Siphon failures have occurred due to slope movement causing compression buckling and tensional separation of the pipe at expansion/contraction joints and the concrete transition structures (Photos 21 through 23).

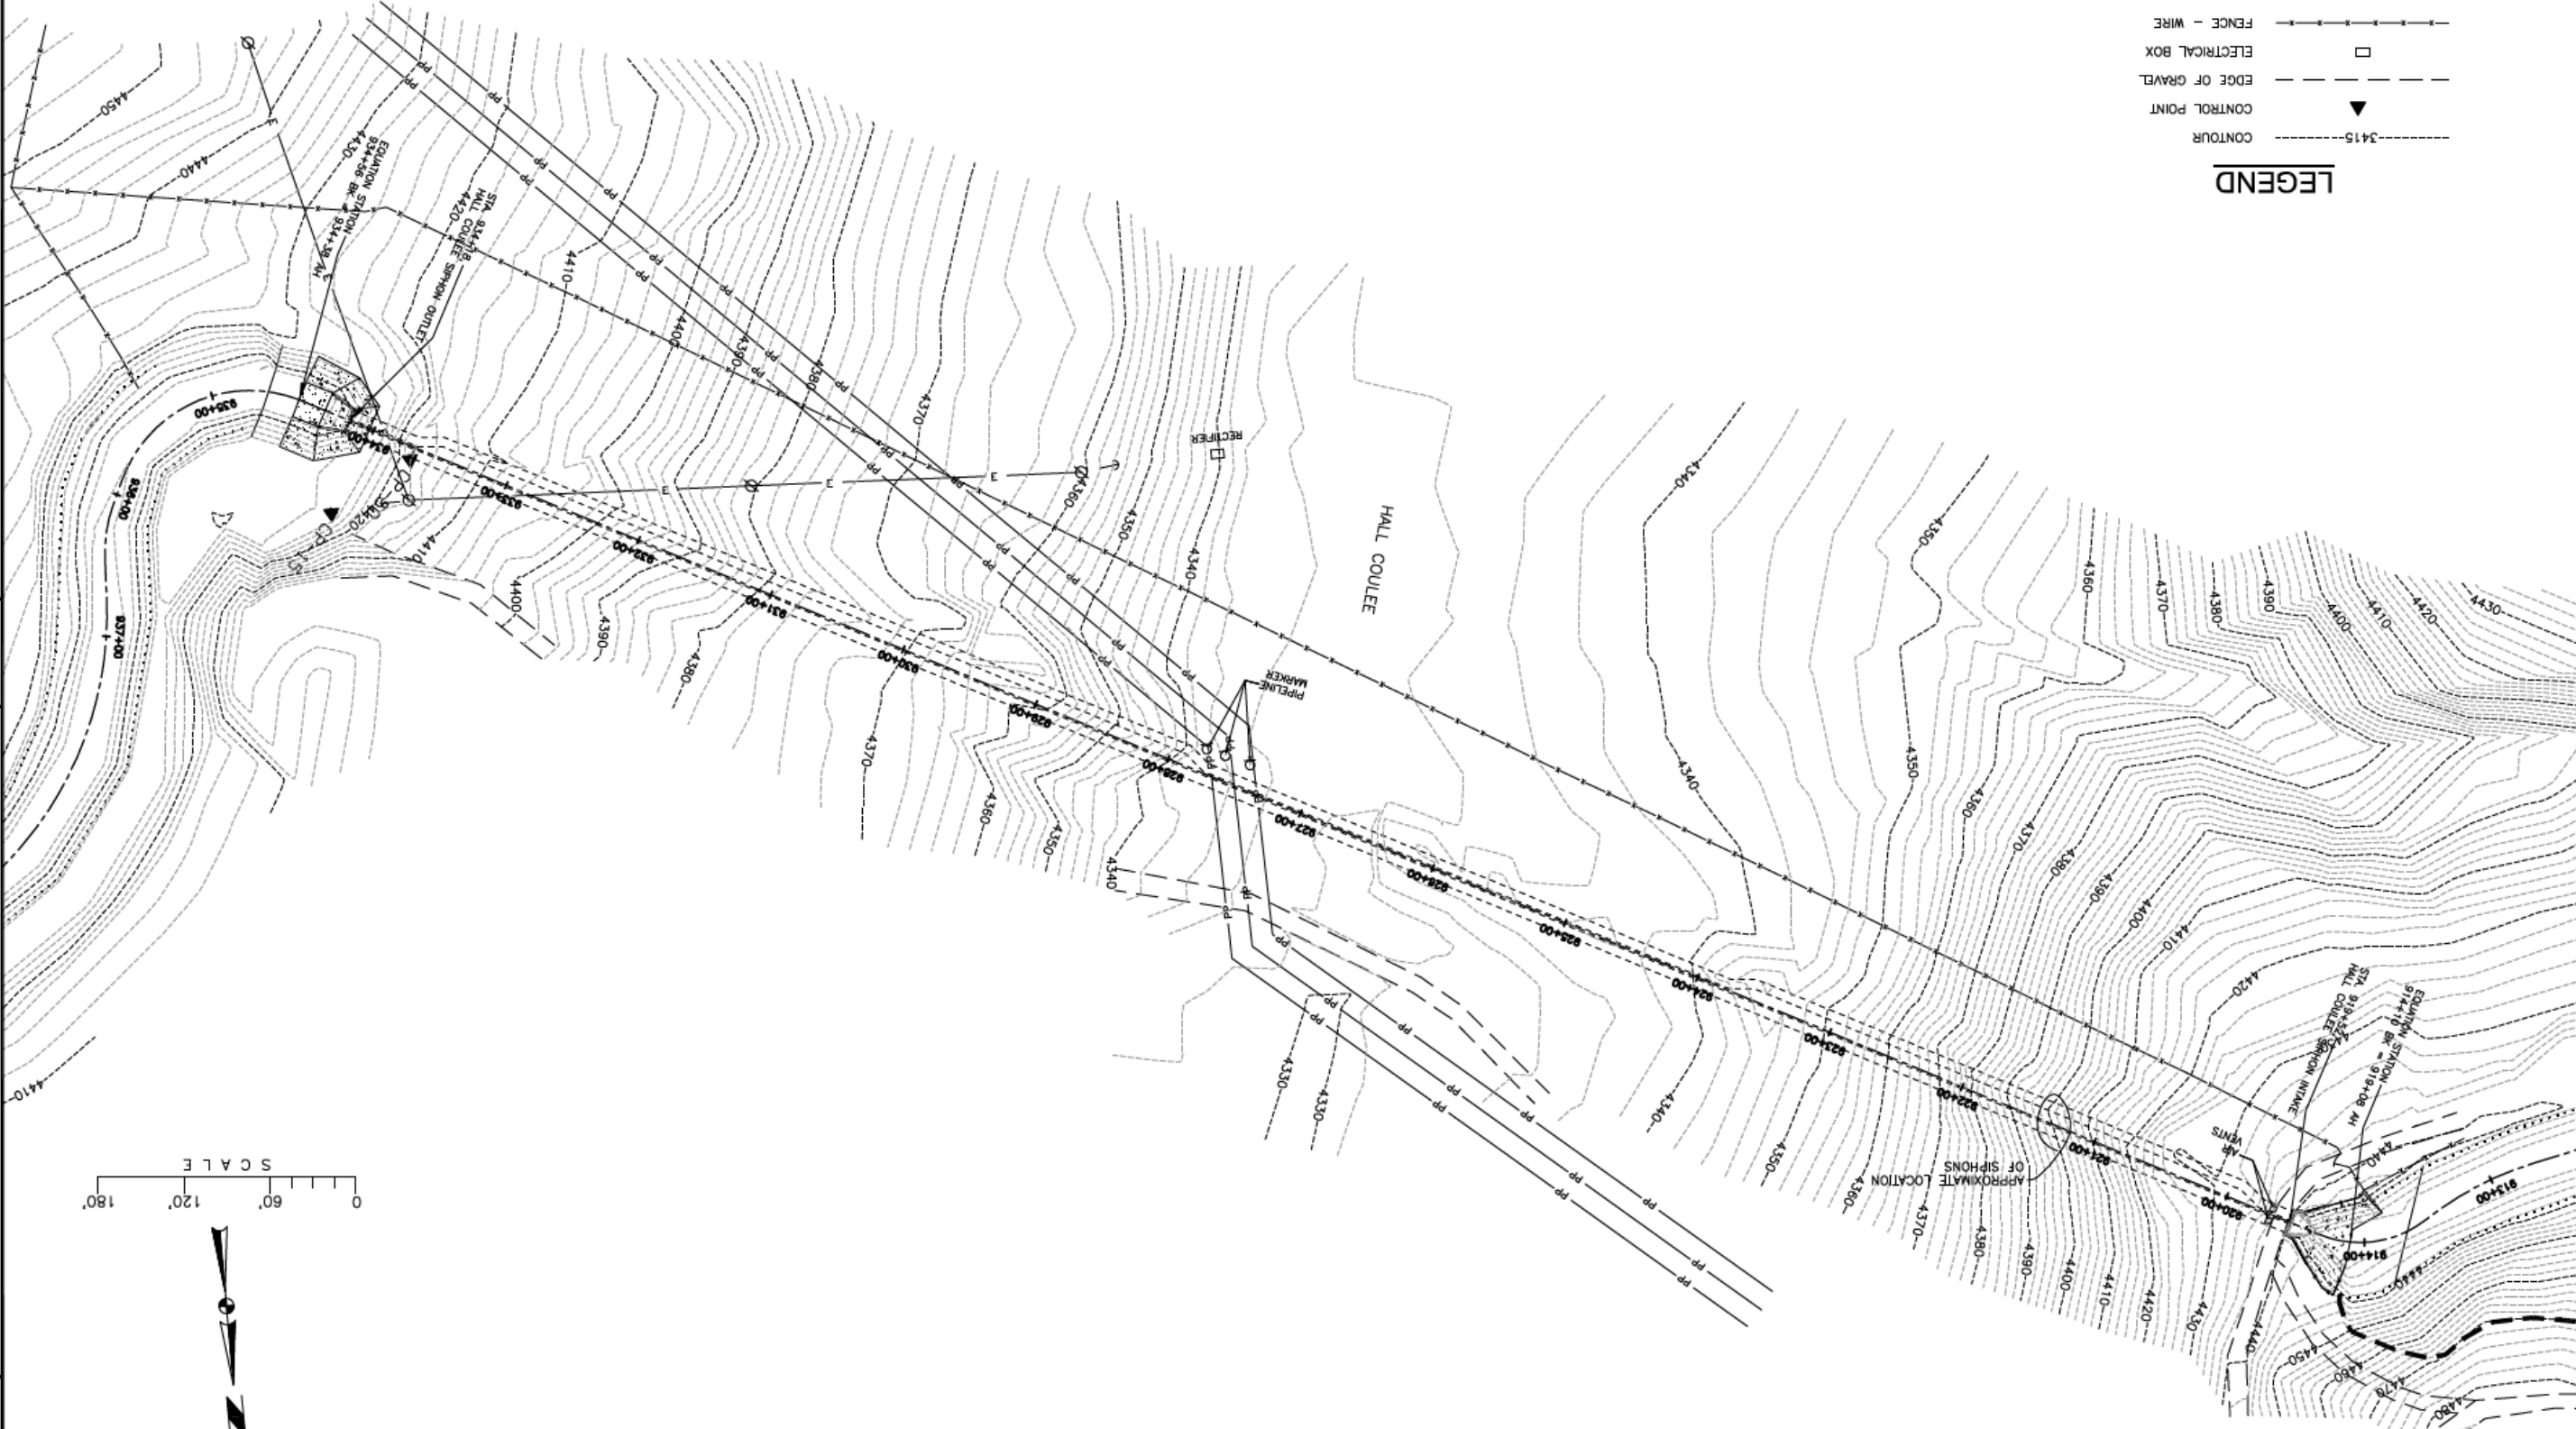
FIGURE 6

The Hall Coulee Siphon (Figure 6) was constructed in two phases with similar construction to the St. Mary River Siphon. (Photos 30 & 31). The Hall Coulee Siphon is relatively stable compared to the St. Mary River Siphon, but has experienced some minor problems with sliding, leakage and closure of expansion/contraction joints (Photo 32).

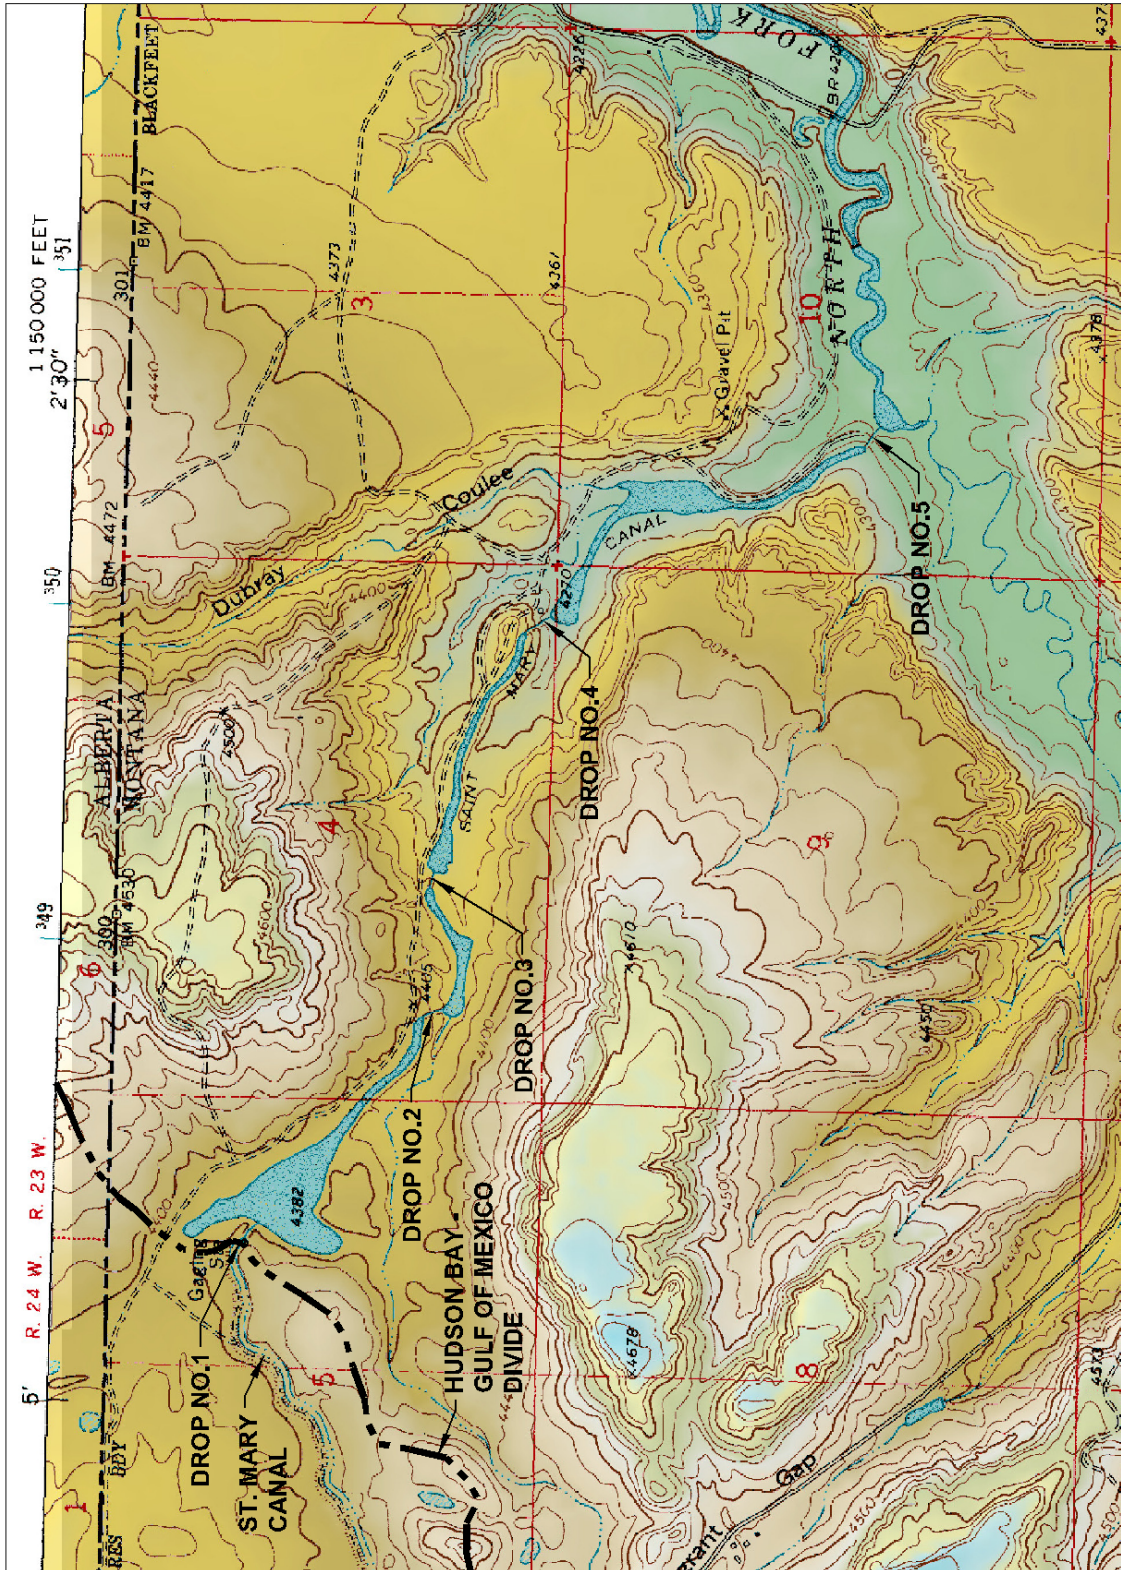
THOMAS, DEAN & HOSKINS, INC. ENGINEERING CONSULTANTS MONTANA SPOKANE WASHINGTON IDAHO		
	DRAWN BY: WAR DESIGNED BY: EAJ QUALITY CHECK:	DATE: 11/24/08 JOB NO. 04107 CAD NO. 04107-487	FIGURE 7

The St. Mary Canal discharges to the North Fork Milk River after passing over the Hudson Bay - Gulf of Mexico Divide (Figure 7). Energy dissipation is achieved through five reinforced concrete drop structures that have a combined drop of approximately 218 feet. Photos 33 and 34 show drops 1 and 2 operating.
